I-90 / I-39 Full Depth Asphalt – 7 Year Performance

Steve Gillen
Illinois Tollway

Illinois Asphalt Pavement Association

March 9, 2015

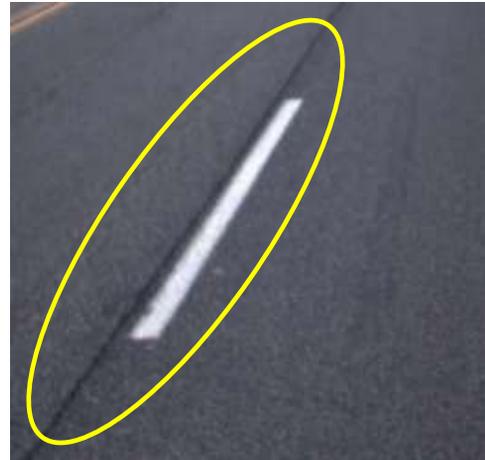
Condition of Mainline I-90 Pavements: EB MP 2.5-18

- **Distresses**
 - **Minor transverse and longitudinal cracking**
 - **Minor to moderate longitudinal joint cracking/seam separation**
 - **All longitudinal joints to be routed & sealed in 2015**

Minor longitudinal joint cracking & separation

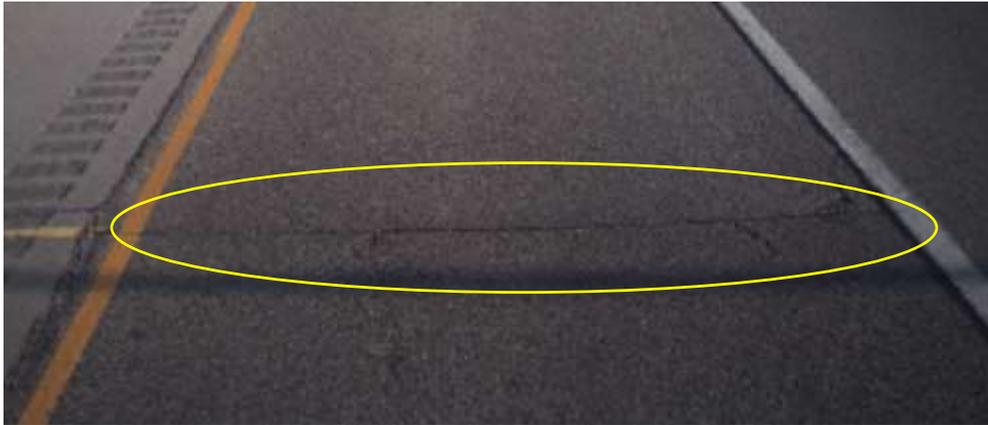
Condition of Mainline I-90 Pavements: WB MP 18-7.5

- Minor & isolated transverse cracking
- Minor to moderate longitudinal joint cracking/separation

Minor transverse cracking

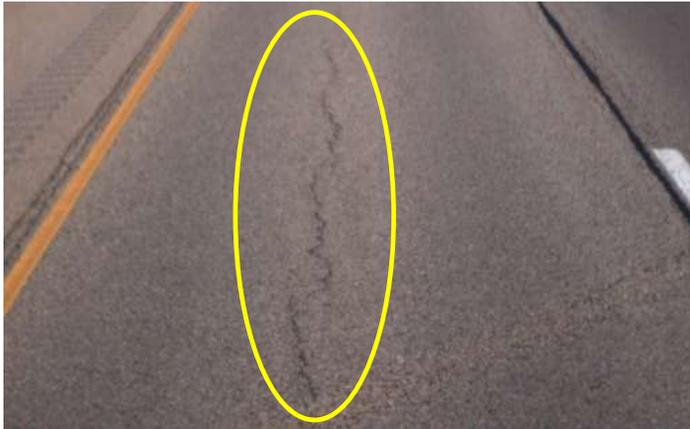
Condition of Mainline I-90 Pavements: WB MP 7.5-2.5

- Minor transverse and longitudinal cracking
- Minor to moderate longitudinal joint cracking/separation

Minor longitudinal cracking

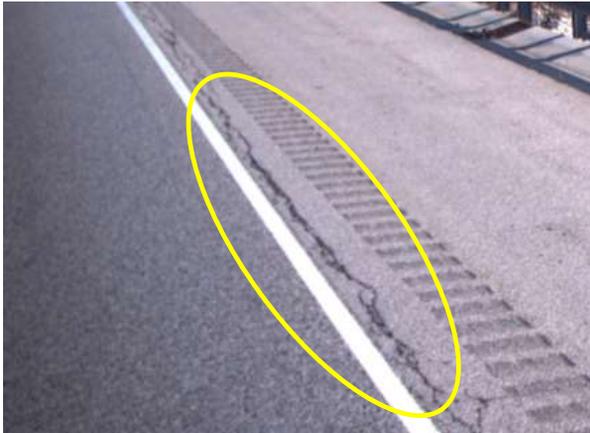
Condition of RAS test strips on WB I-90 outside shoulders: MP 7.5-4.0

- Minor but consistent transverse and longitudinal cracking
- Minor to moderate longitudinal joint cracking/spalling

Moderate longitudinal joint cracking/spalling

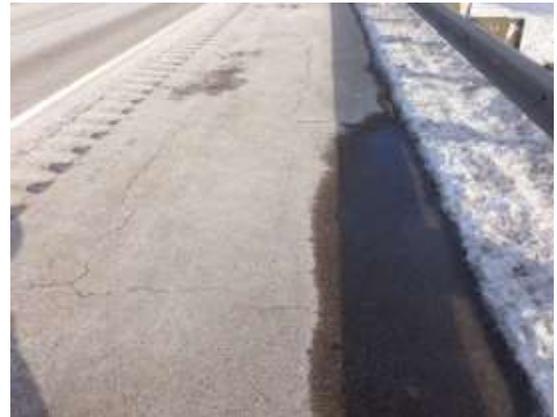
Map Cracking

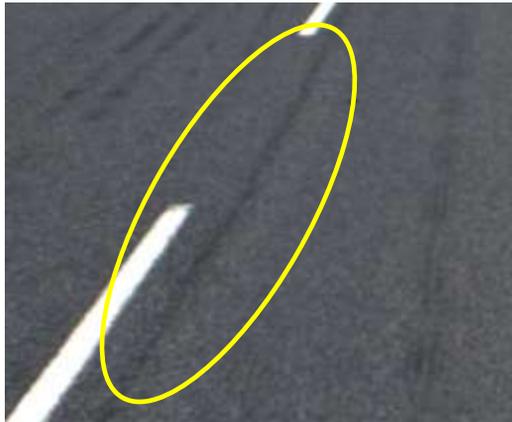
Condition of I-90 WB Exit Ramp at Irene Road

- **2009: No visible distresses**
- **2012: Minor longitudinal cracking in a couple of spots**

Minor longitudinal cracking
