# I-70 Extended Life Pavement Performance

Charles Wienrank, P.E.  
Pavement Design Engineer  
IDOT - Bureau of Research

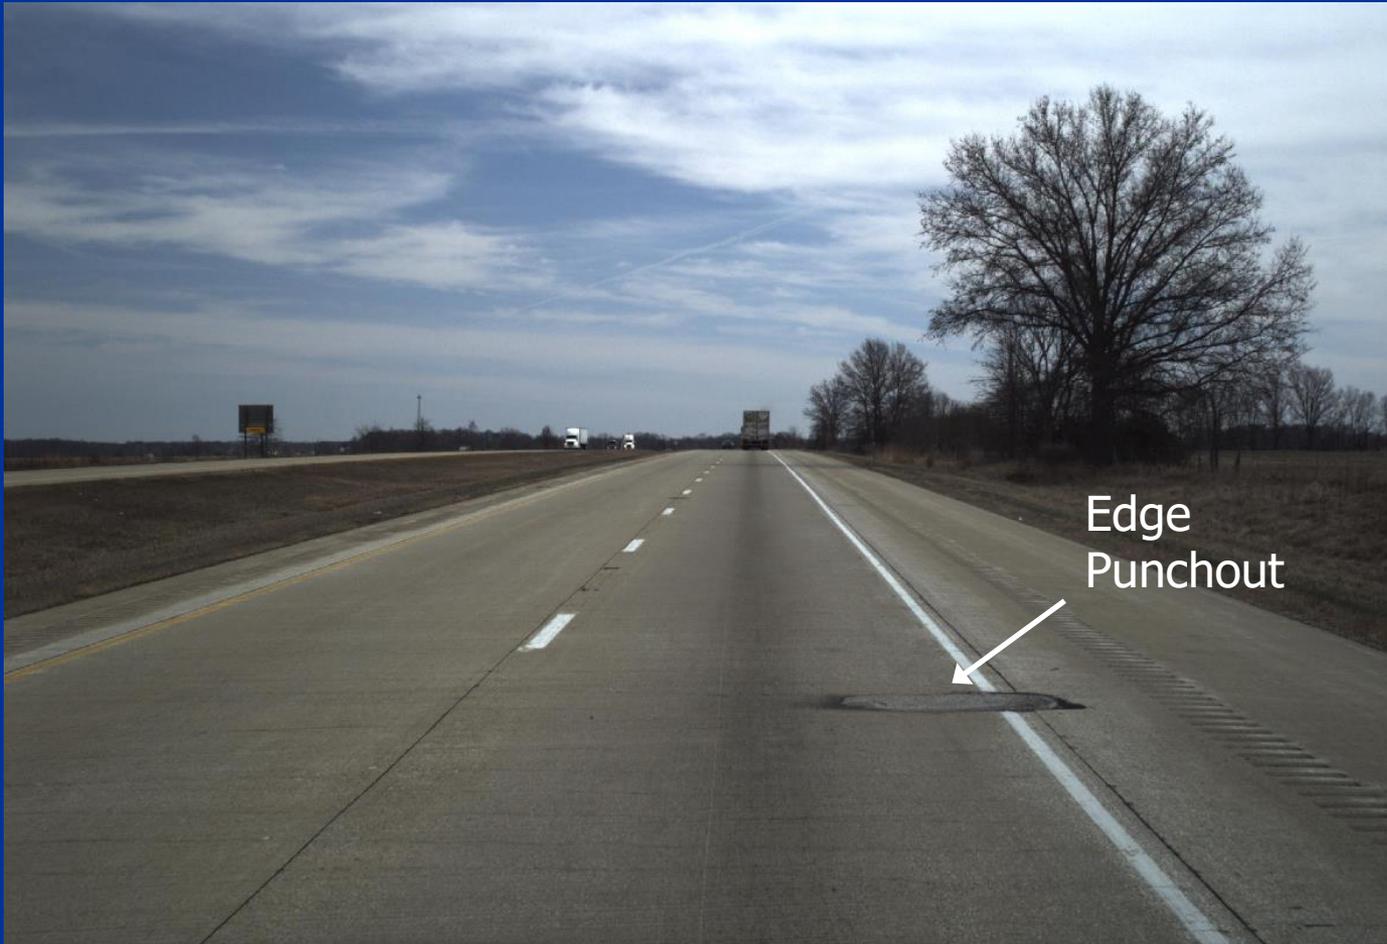
# 2018 DCV Image

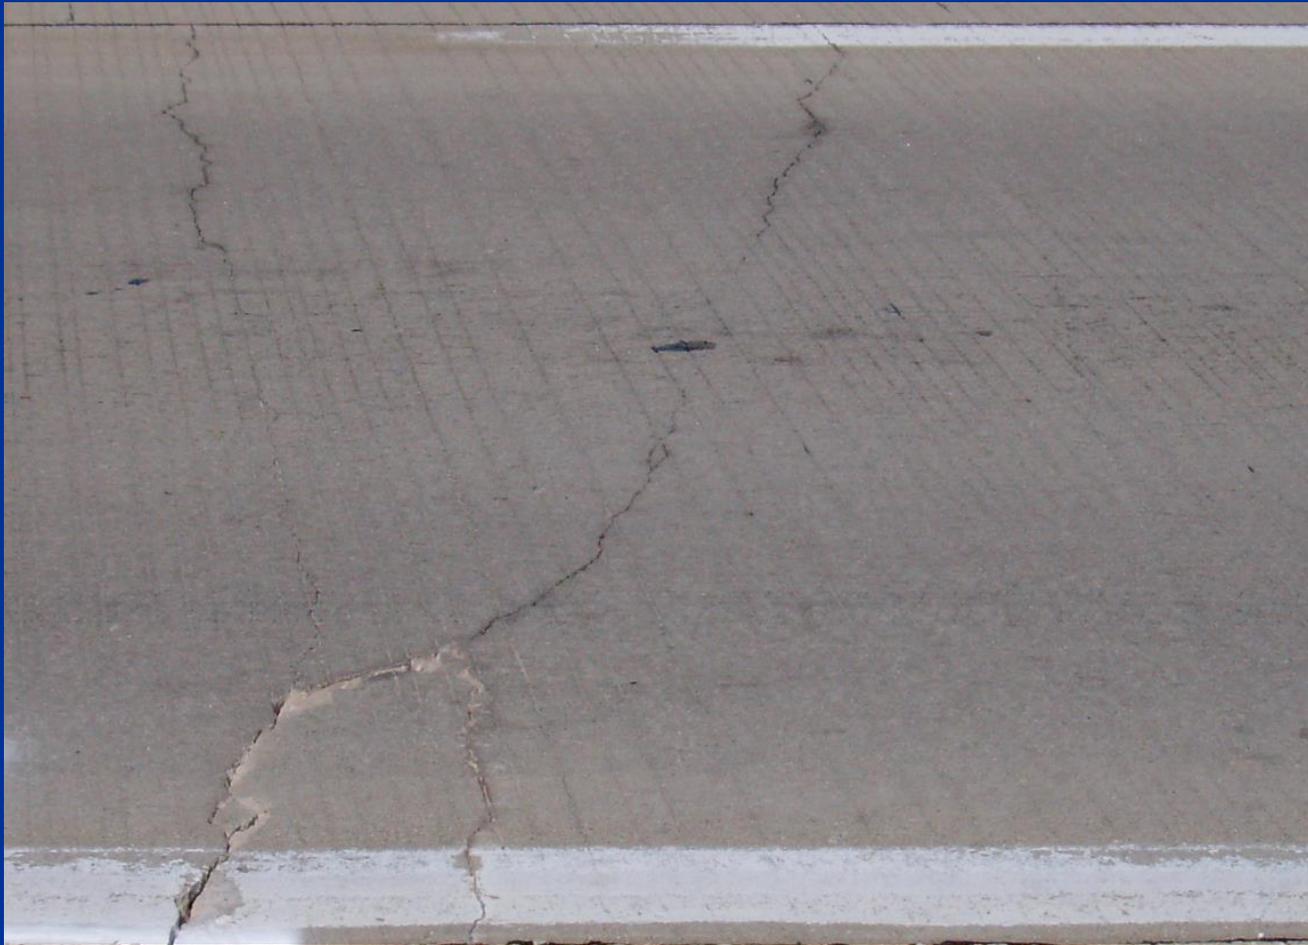
- 2018 CRS=7.7, IRI=75
- Centerline deterioration (low level)
- **Edge punchouts** (around 3 per mile) with (temporary) spray injection patching
- Permanent patching (very little)
- Some warranty repairs

# Edge Punchout

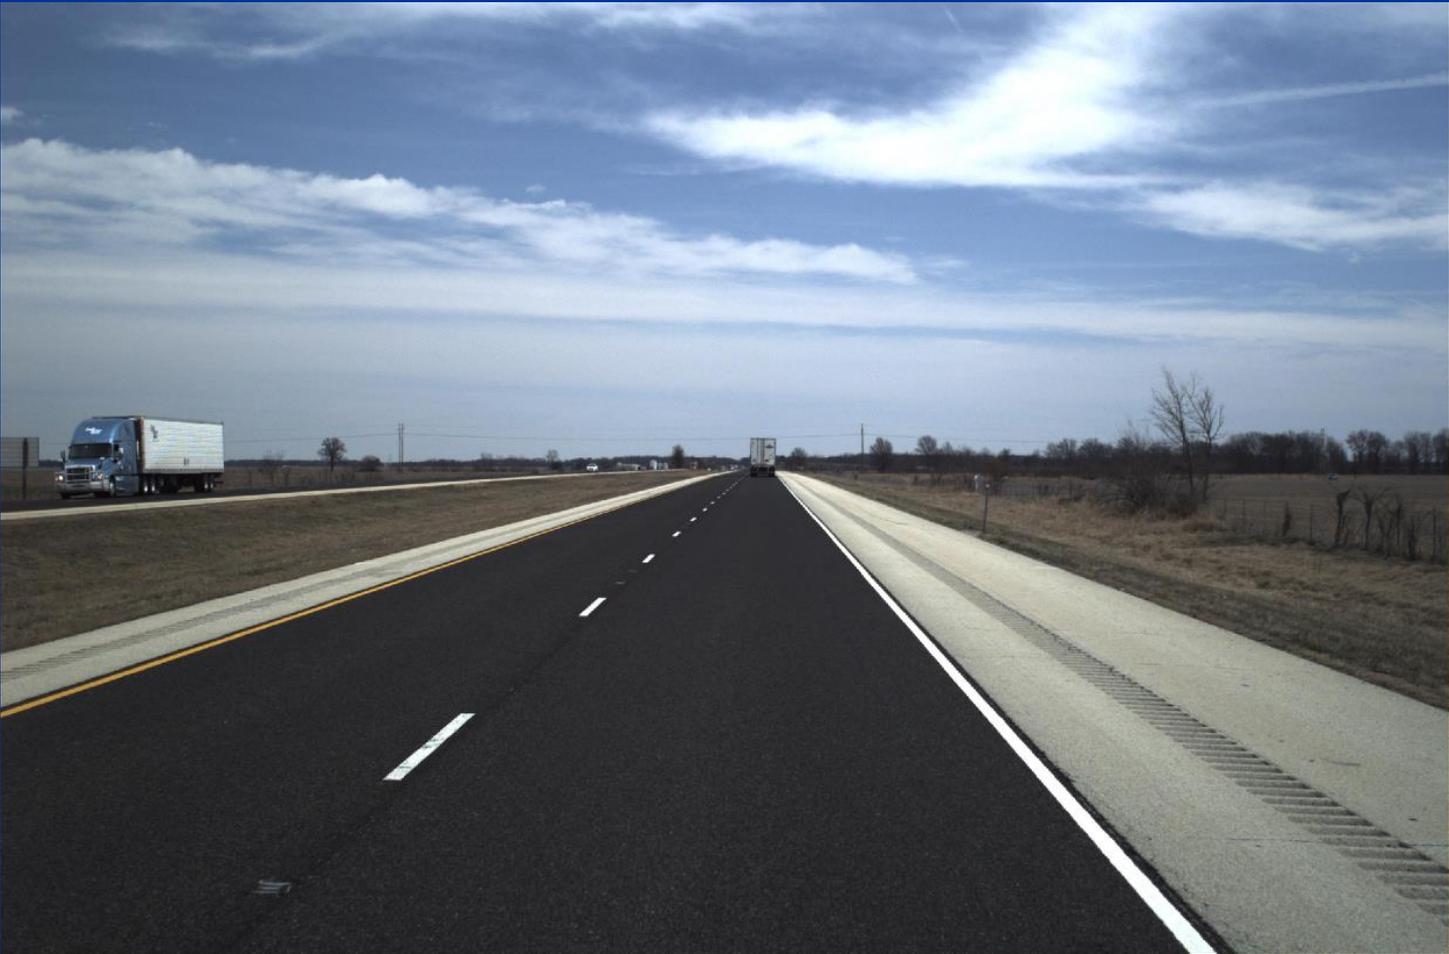
# 2018 DCV Image

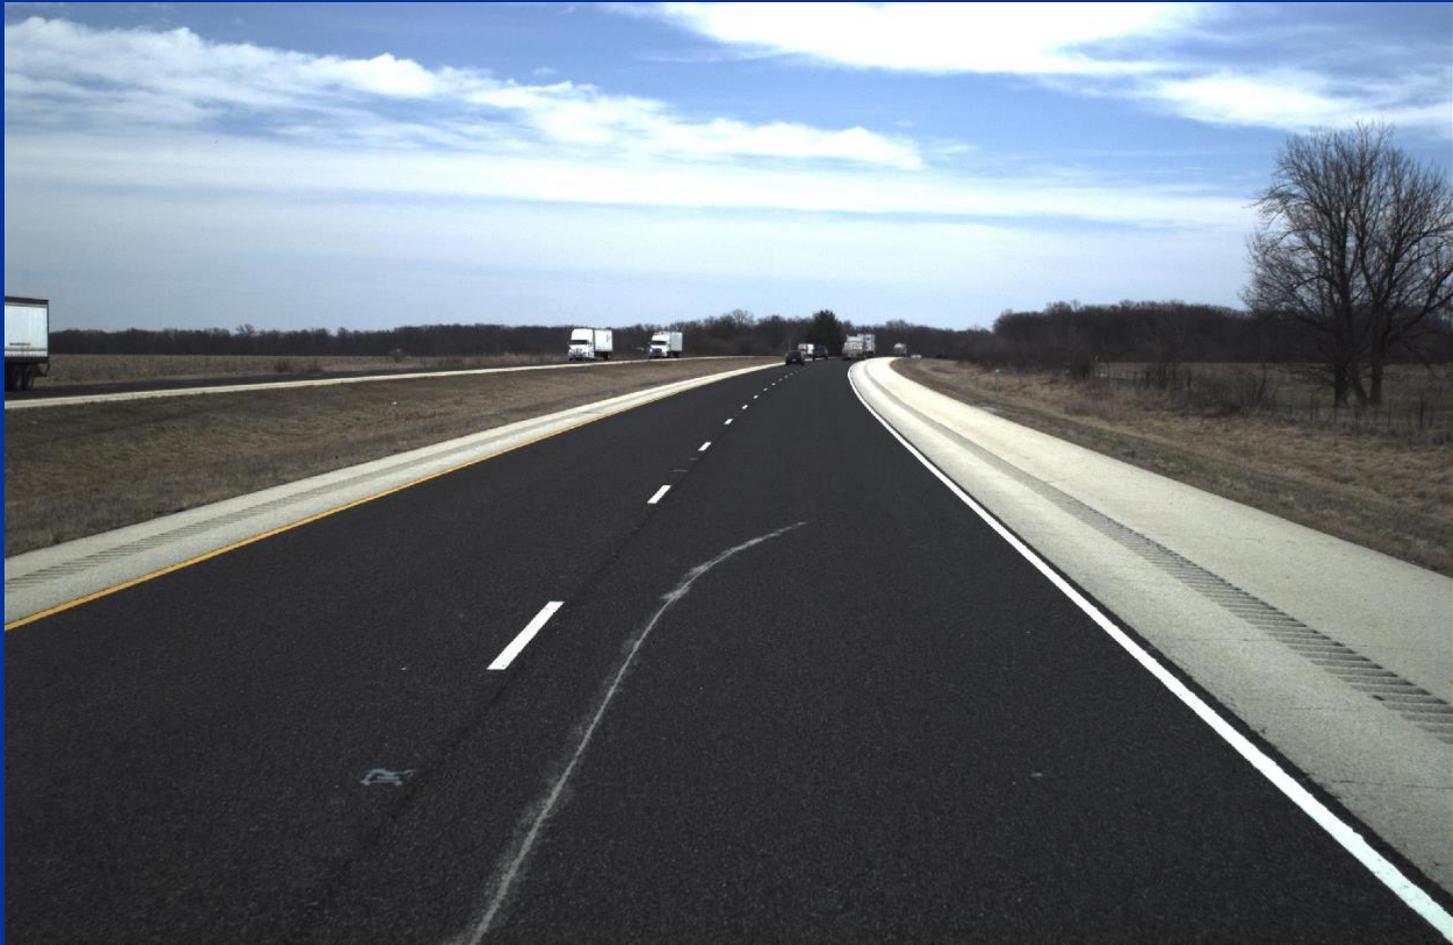
# Mechanical Damage

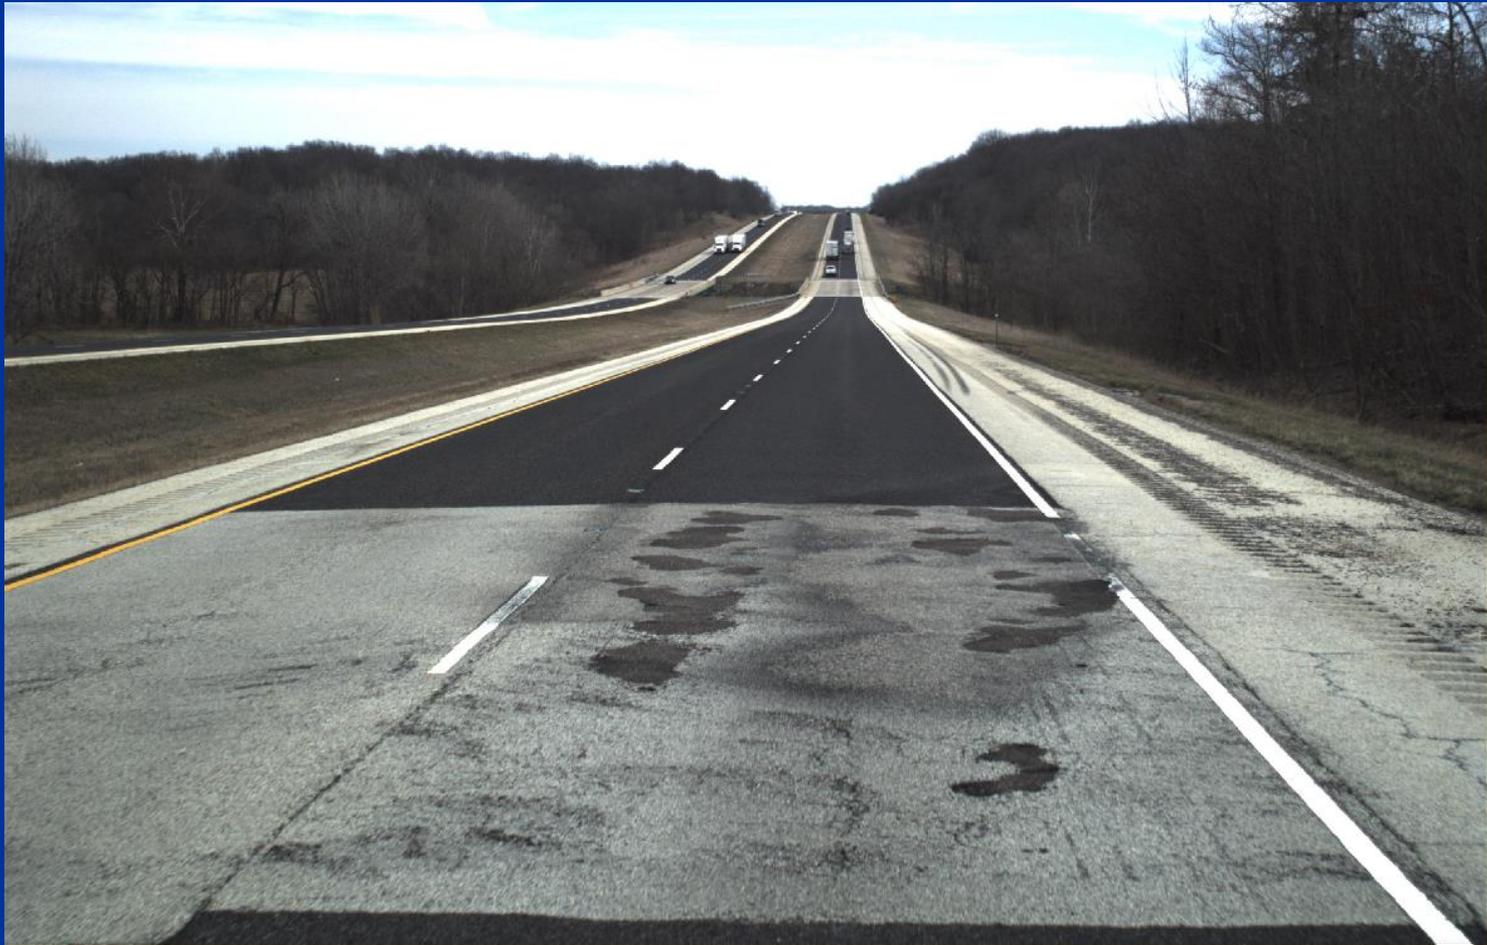
# Car Fire Damage

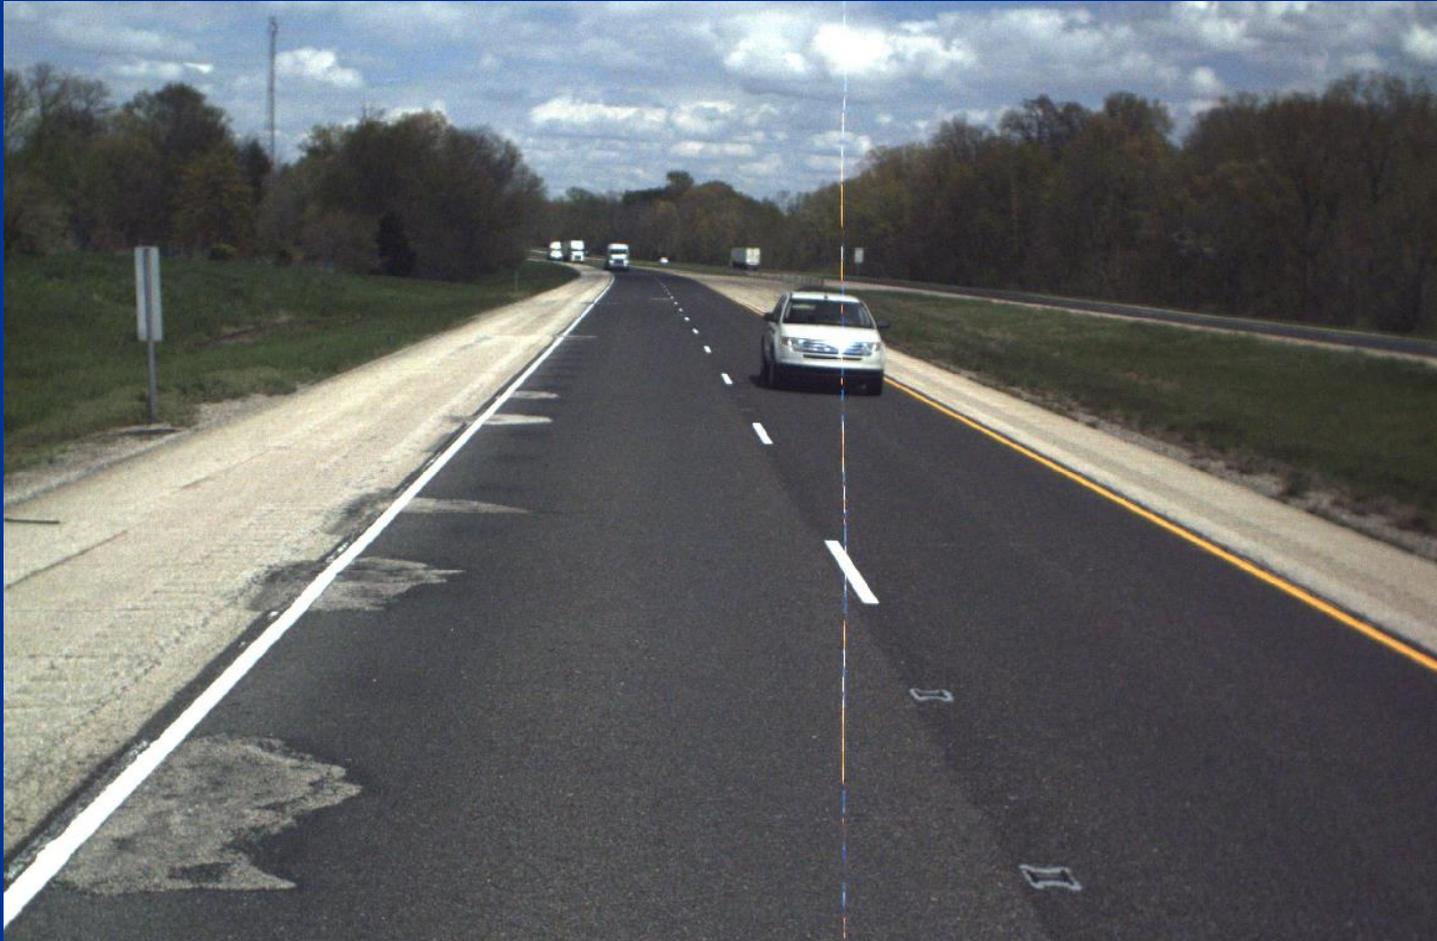
# Reflective D-Cracking
