INTERSTATE RUBBLIZATION AND STAGE CONSTRUCTION

Ross Bentsen, Tollway Engineering Consultant
March 12, 2024

REAGAN MEMORIAL TOLLWAY (I-88)

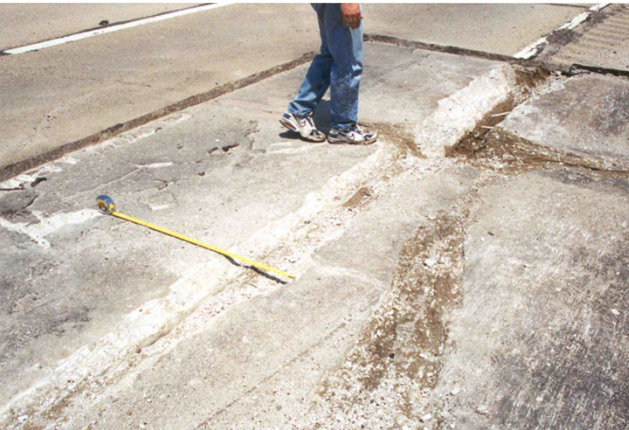
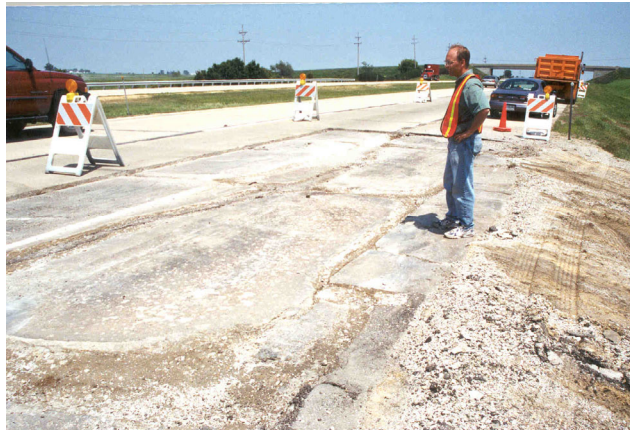
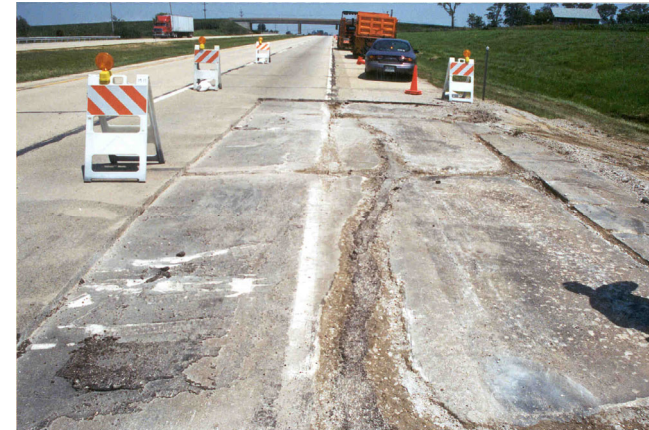
Severe D-cracking of underlying PCC

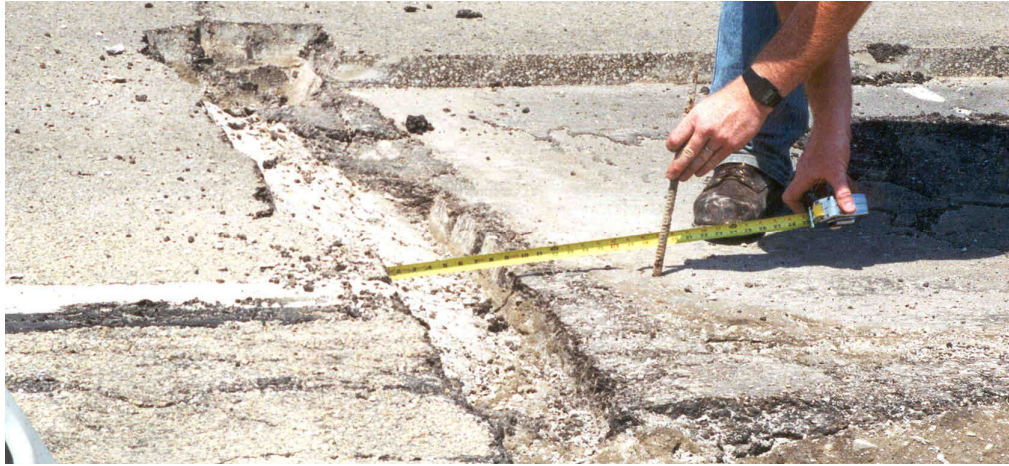
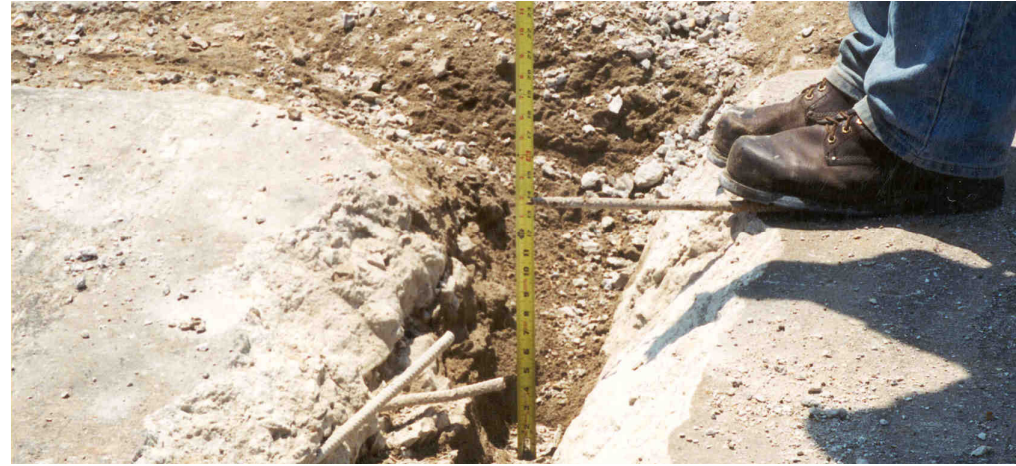
Severity of the problem

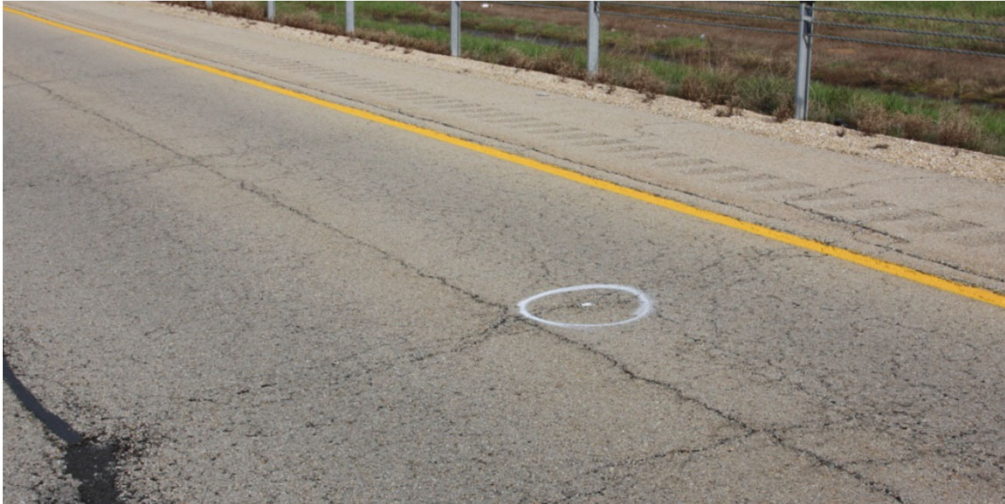
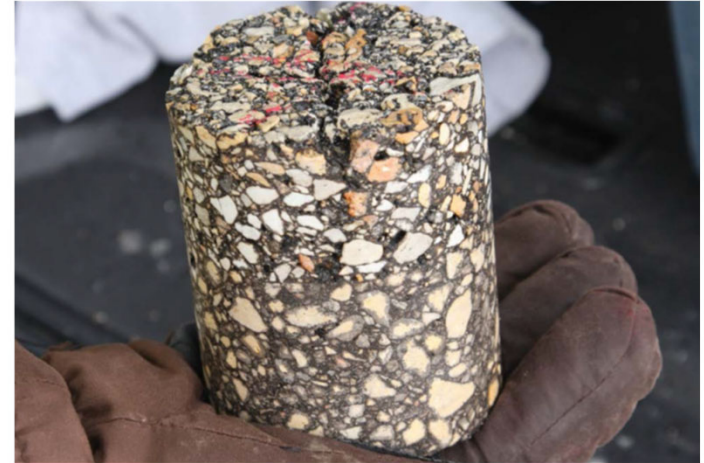
CRACKING EVALUATION – 2011

Top-down cracking

Cracking isolated to the surface (N105 dense-graded)

Mill the deteriorated 2-inch surface course
