FHWA-IDOT

Paver Segregation Process Review

IAPA Convention 2021

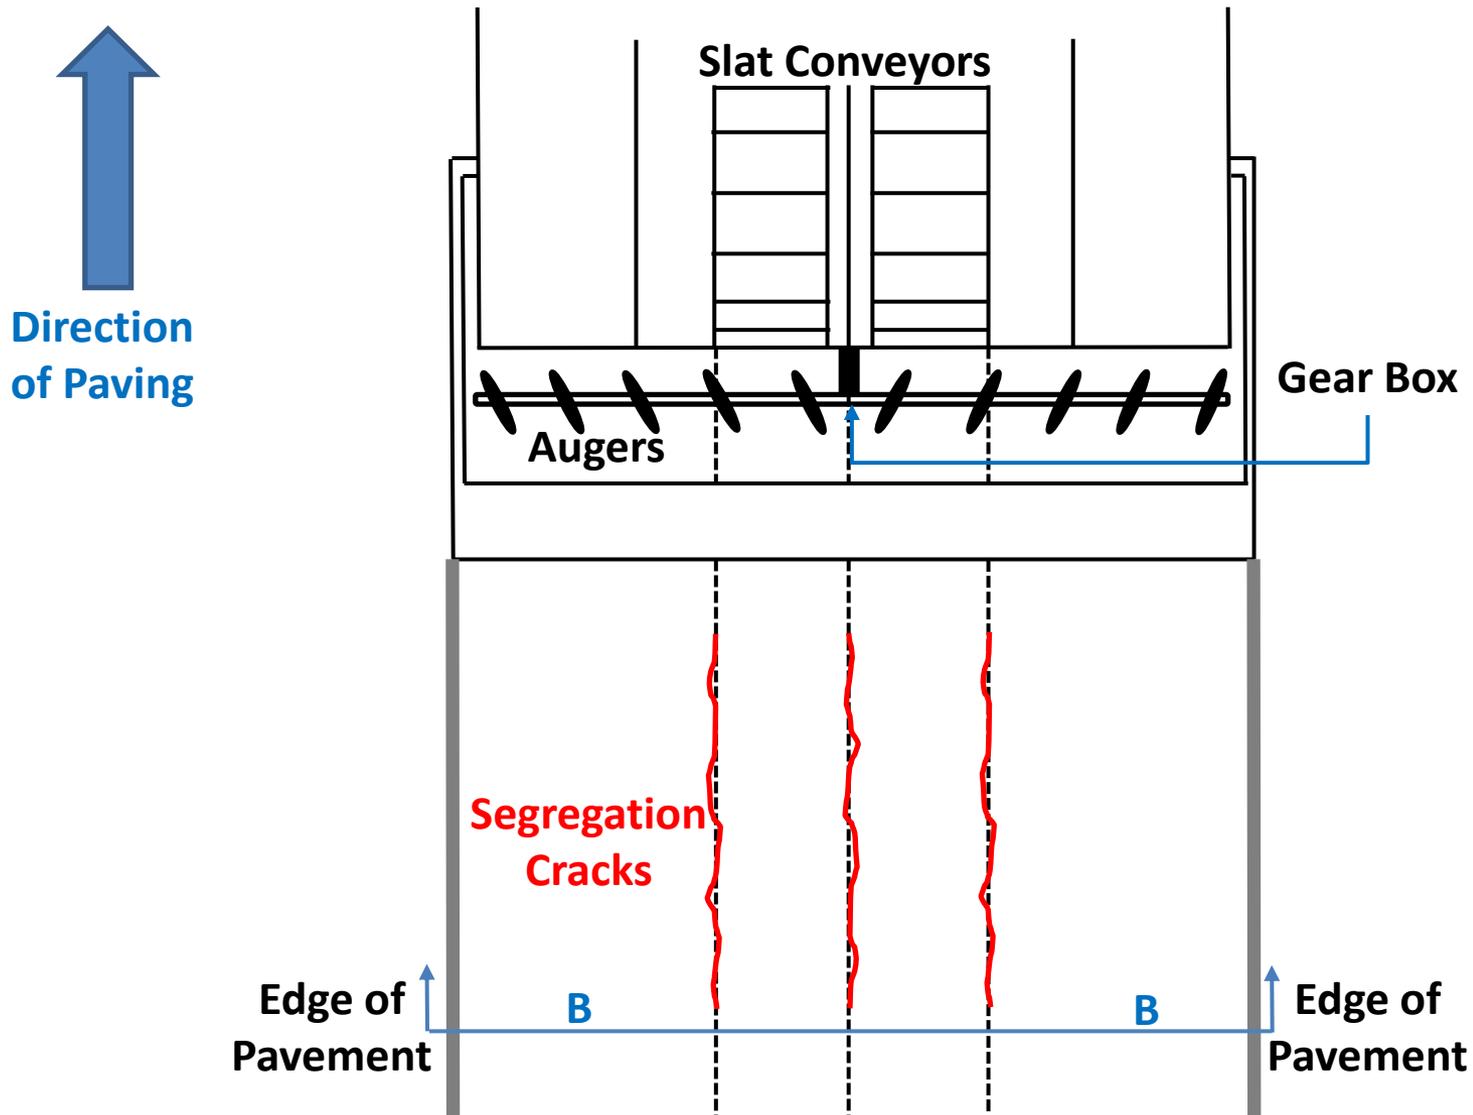
Longitudinal Paver Segregation Schematic

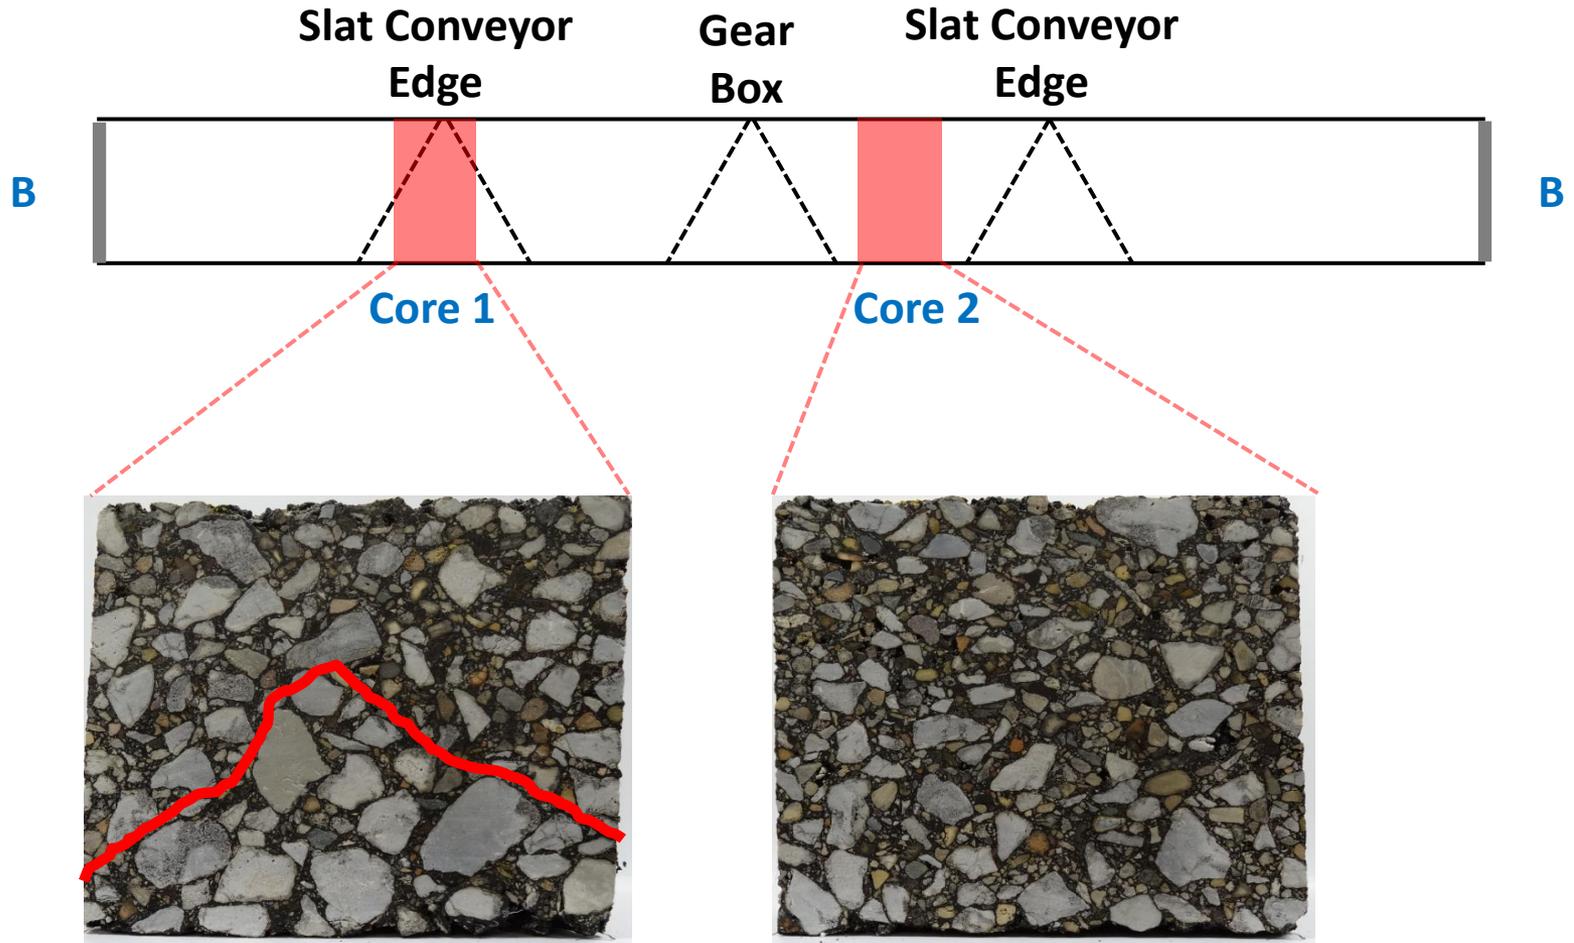
Paver Segregation Schematic – Section B-B

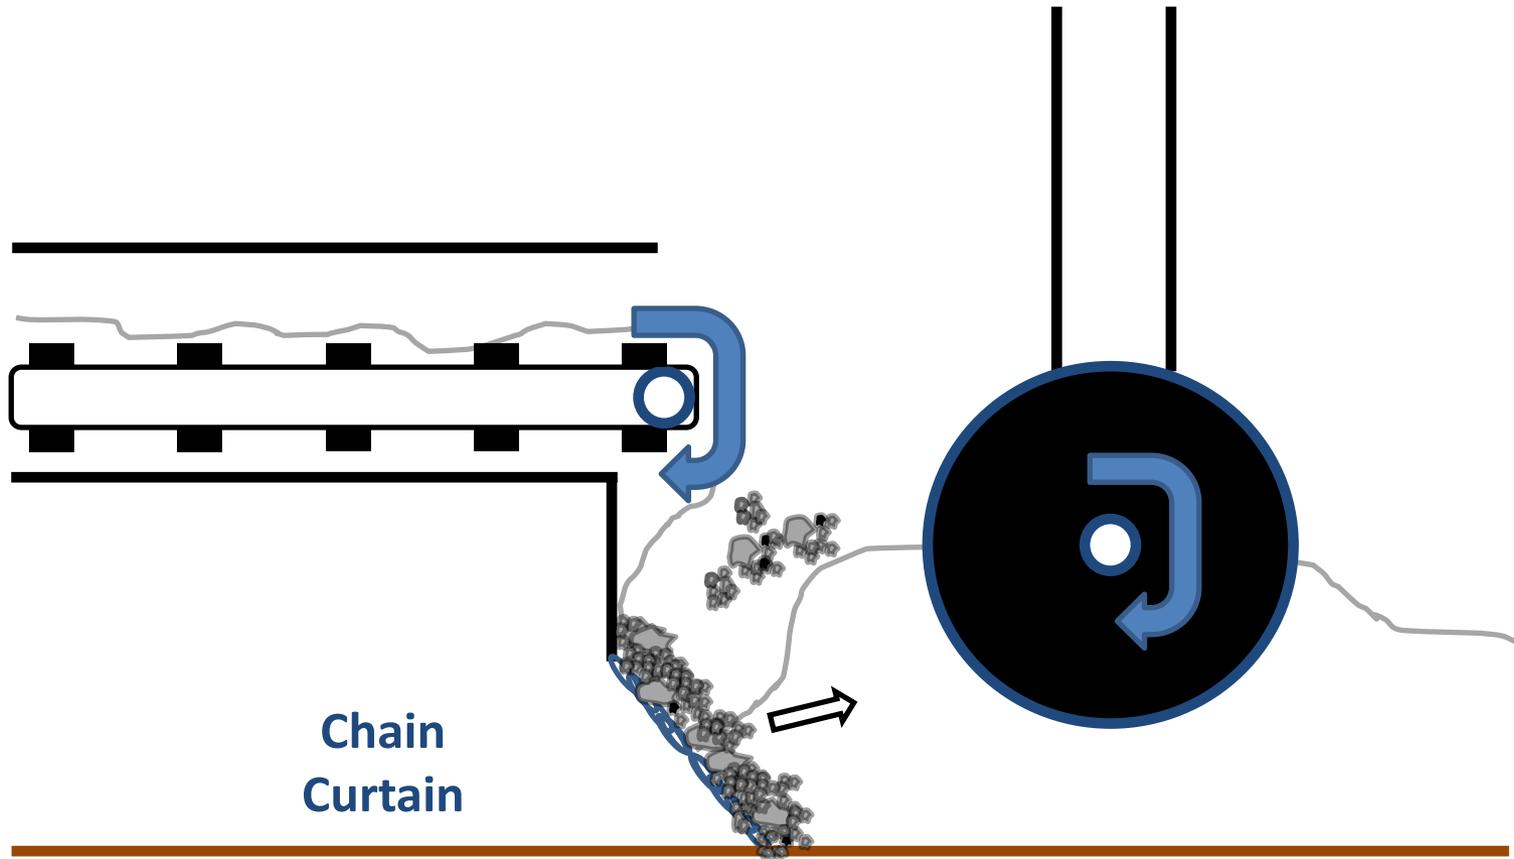
Chain Curtain

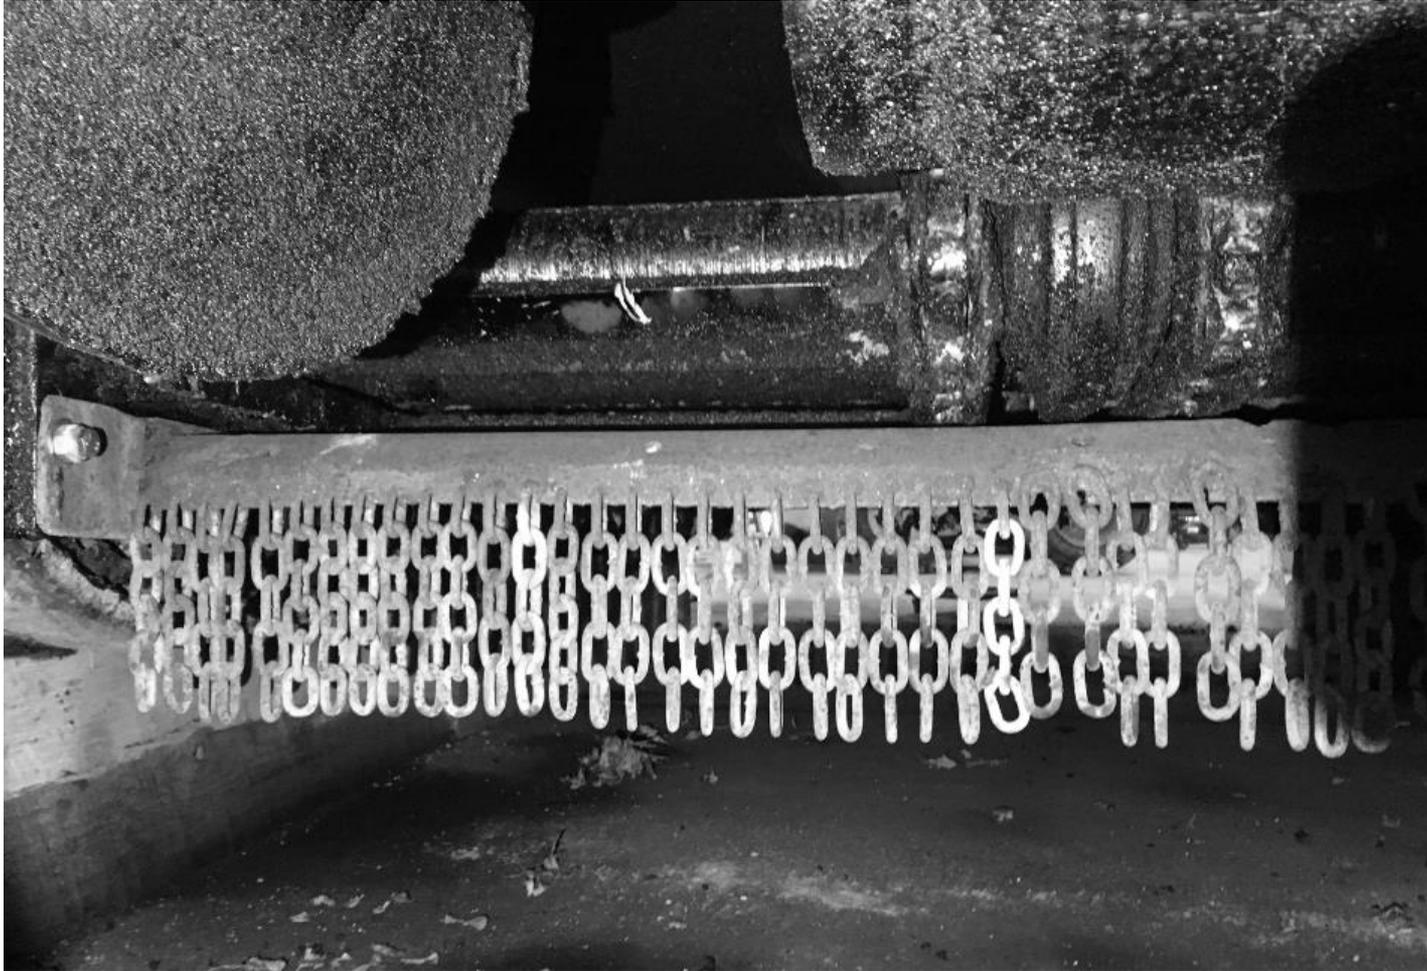
Chain Curtain Example

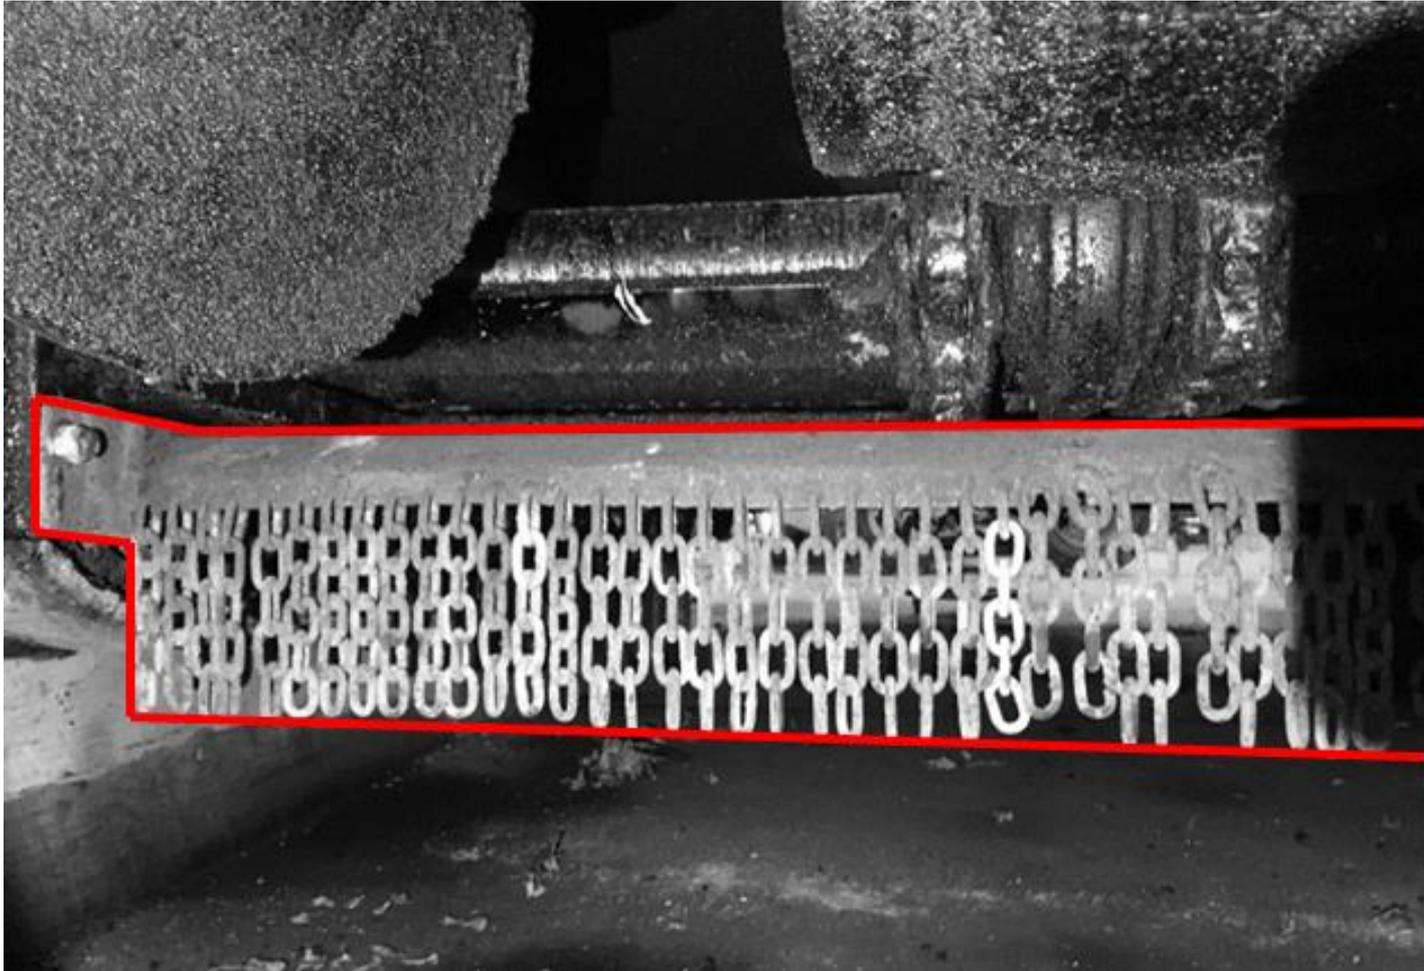
Chain Curtain Example

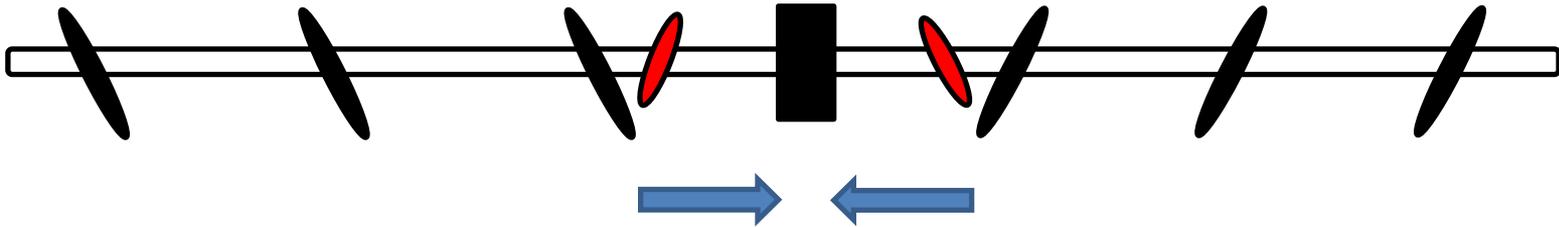
Pushing Material Under Gear Box

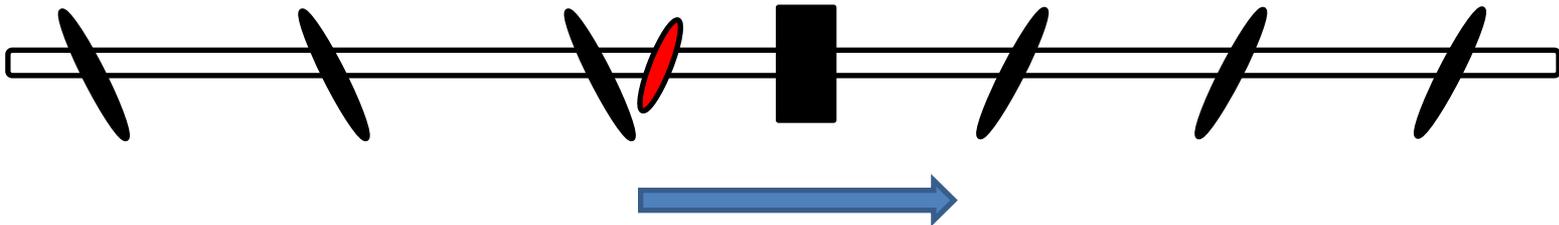
Sweeping Material Under Gear Box

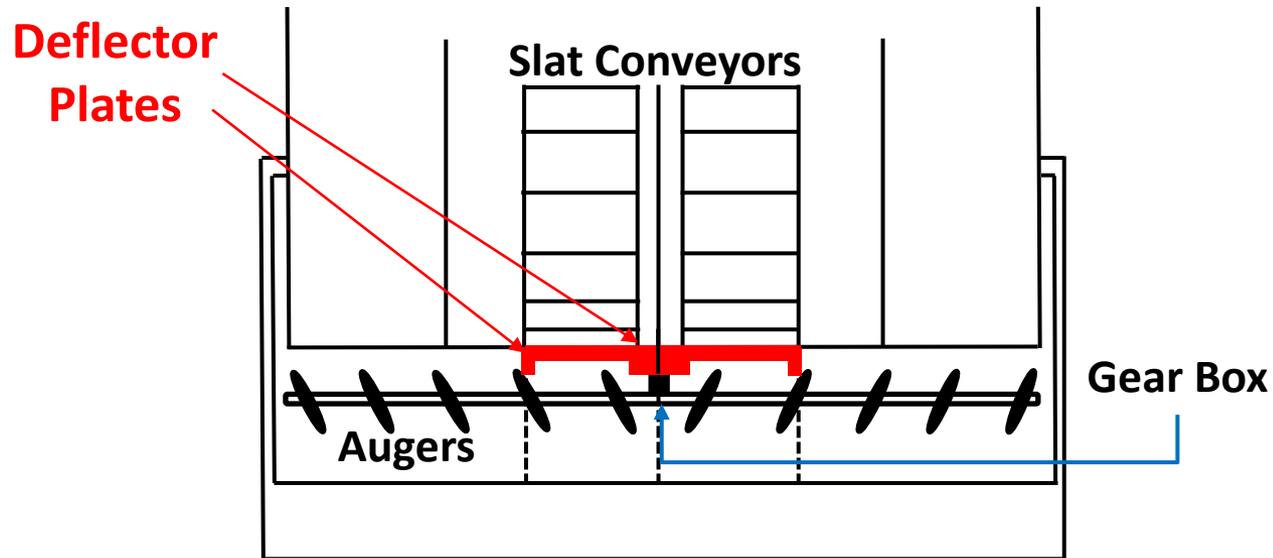
Deflector Plates – Top View

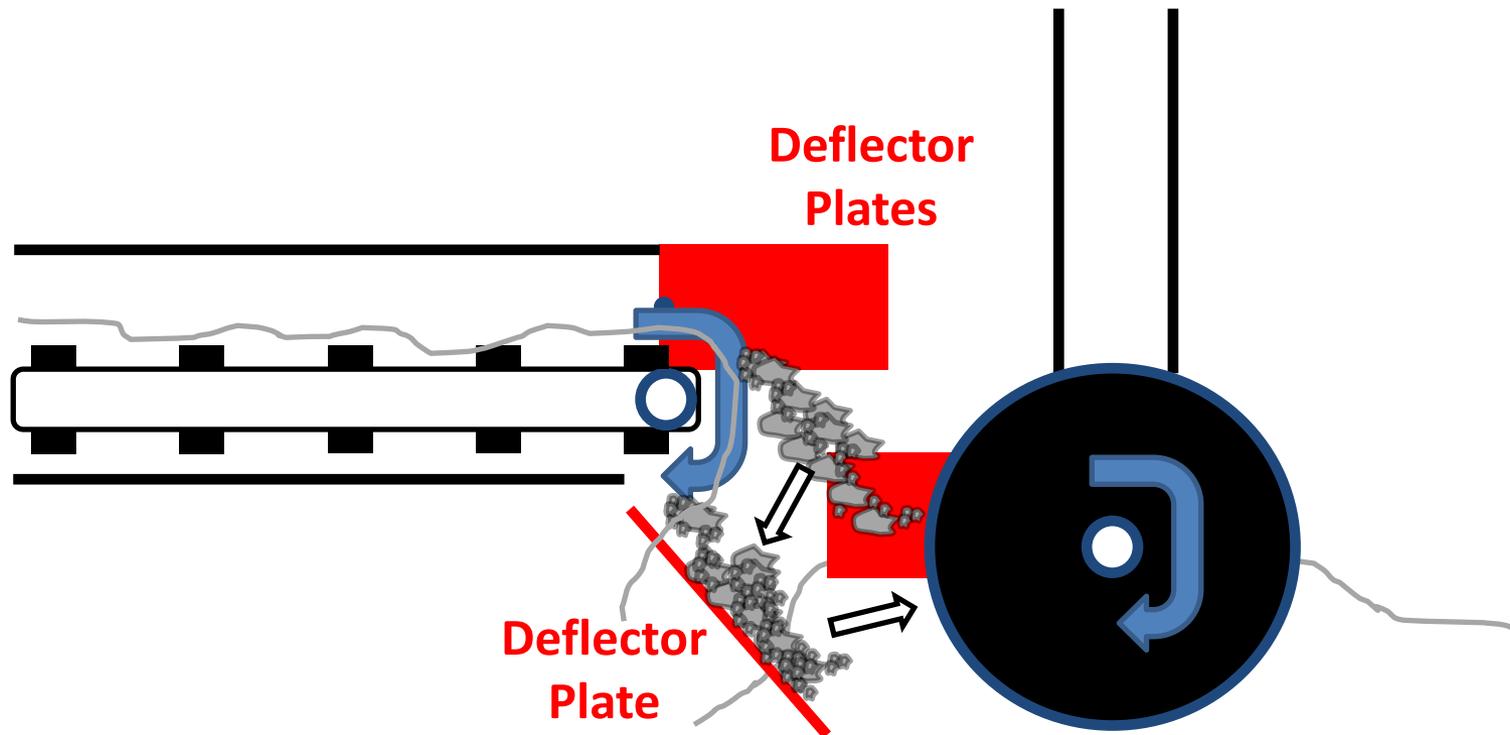
Deflector Plates – Side View

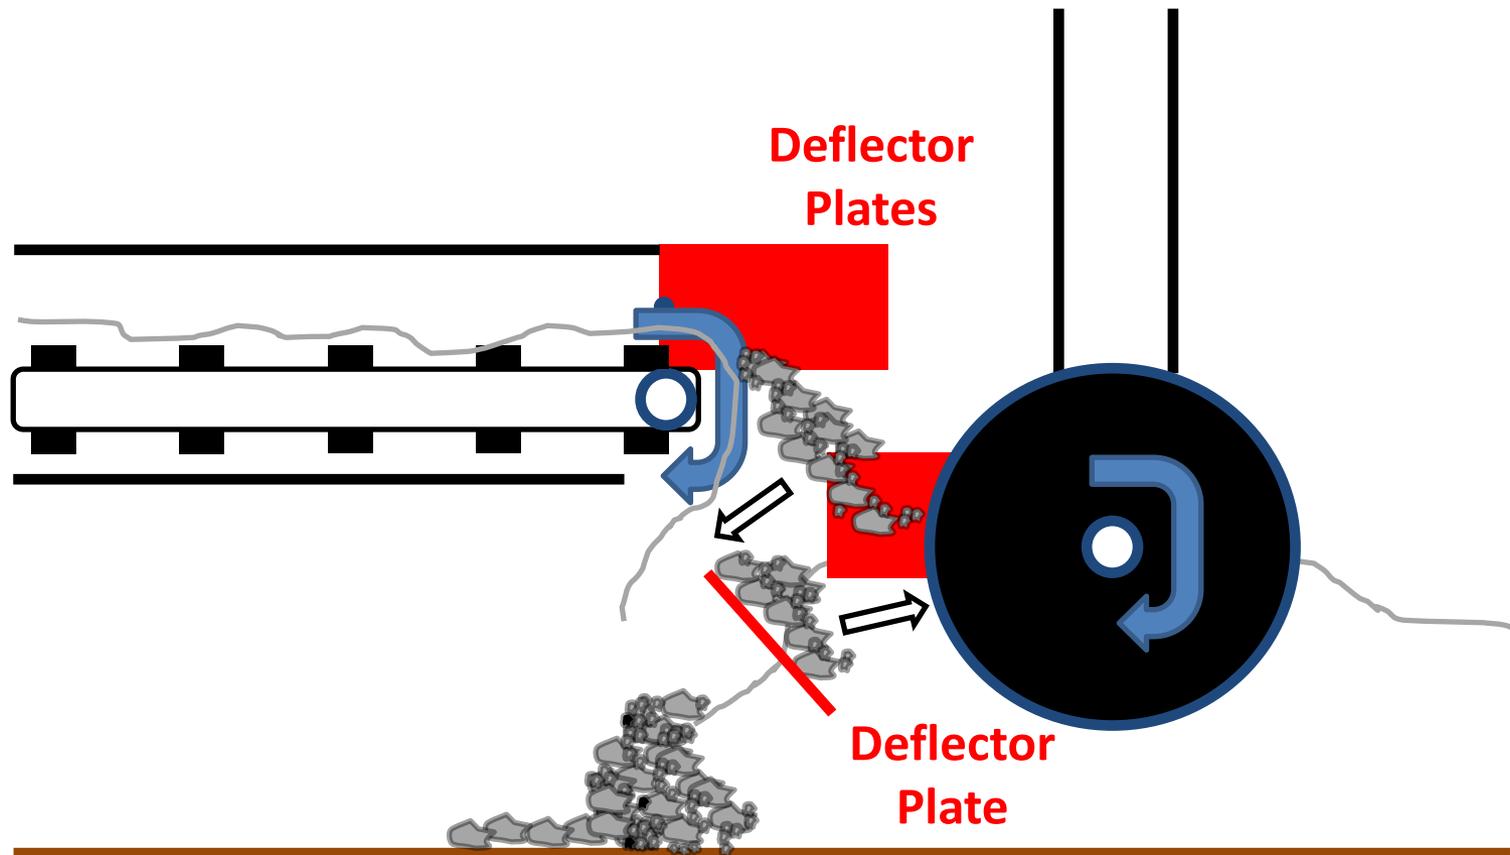
Deflector Plates – Side View

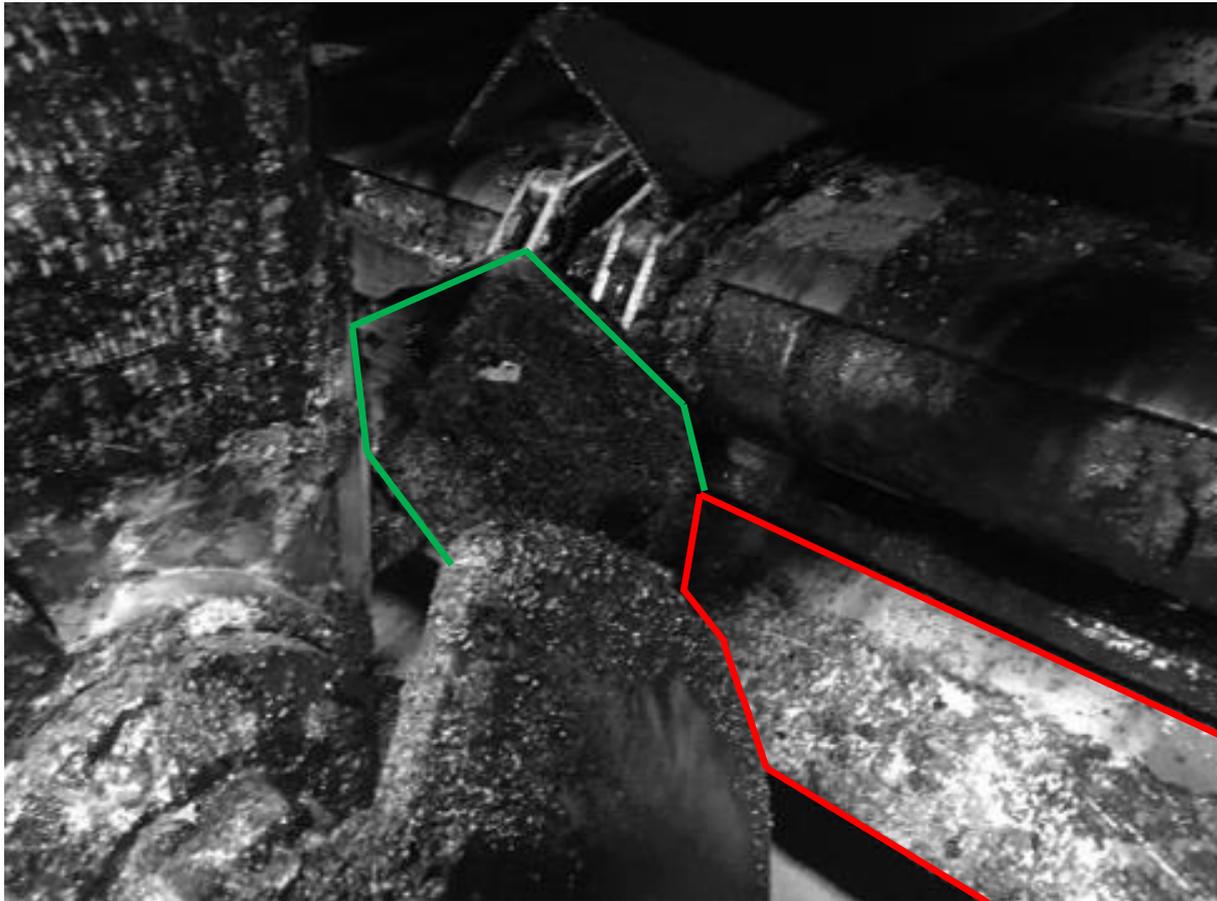
Deflector Plate Example

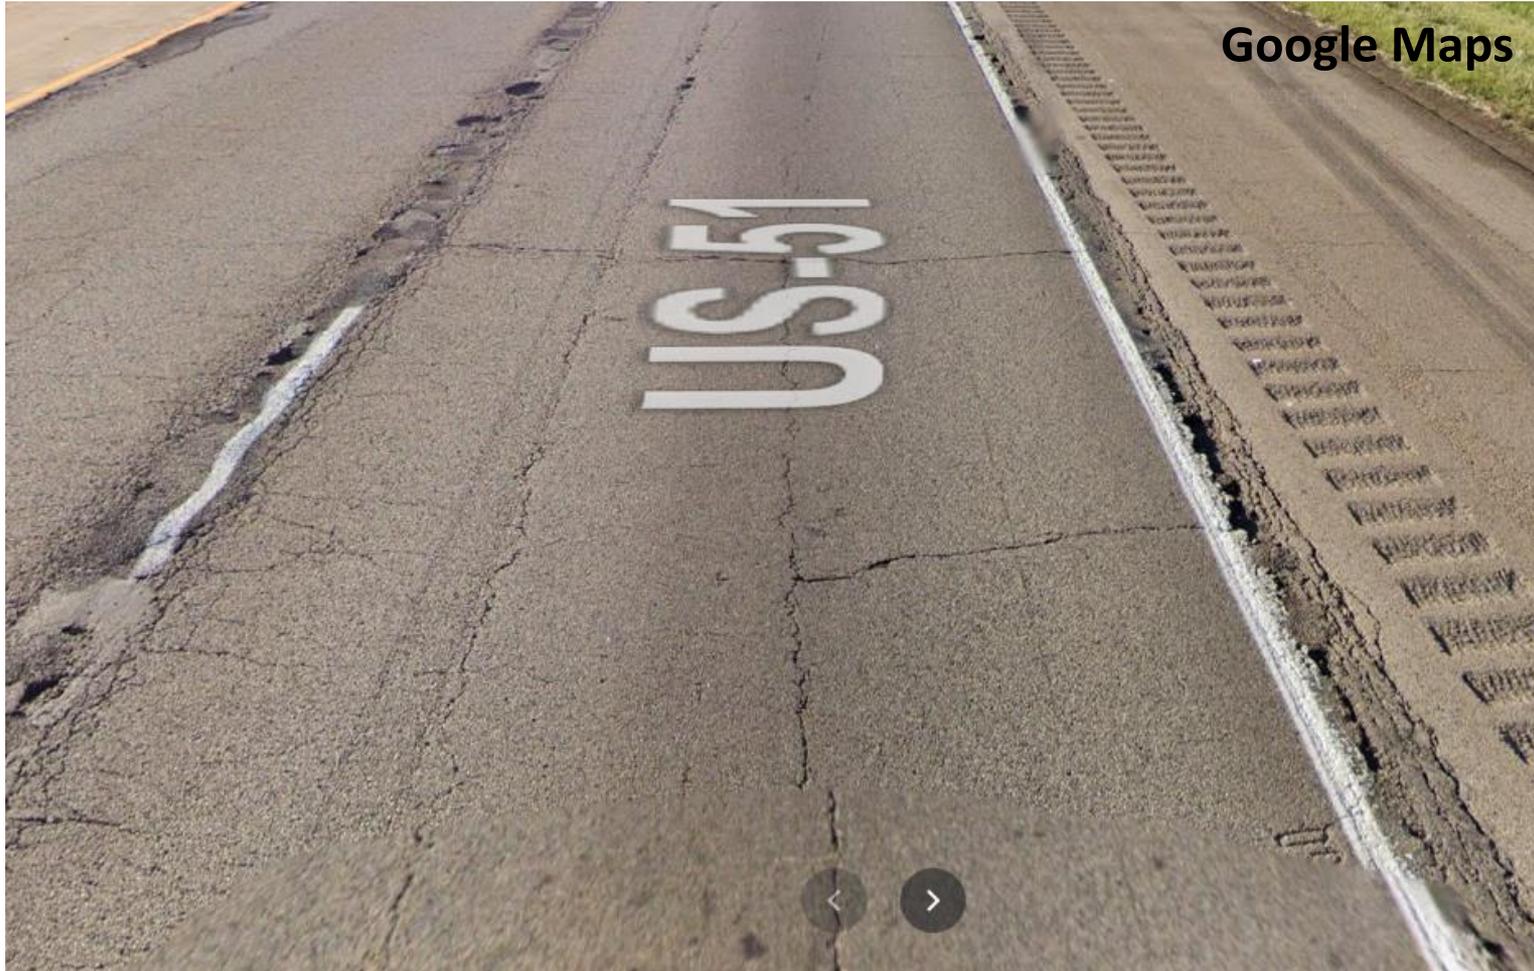
US-51

Paver Segregation Example

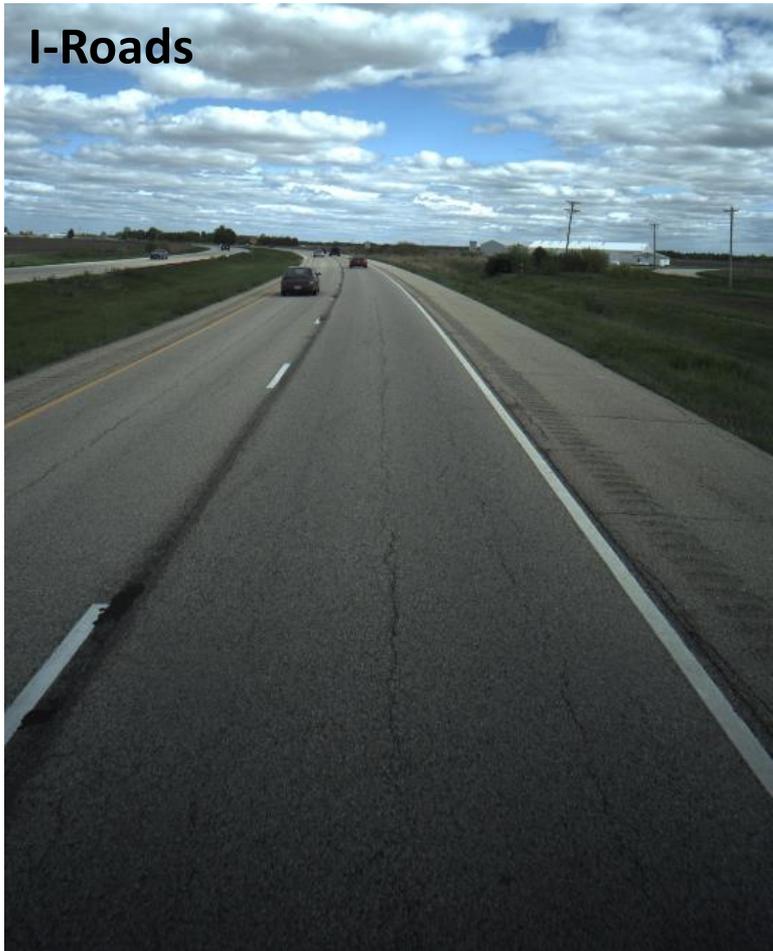
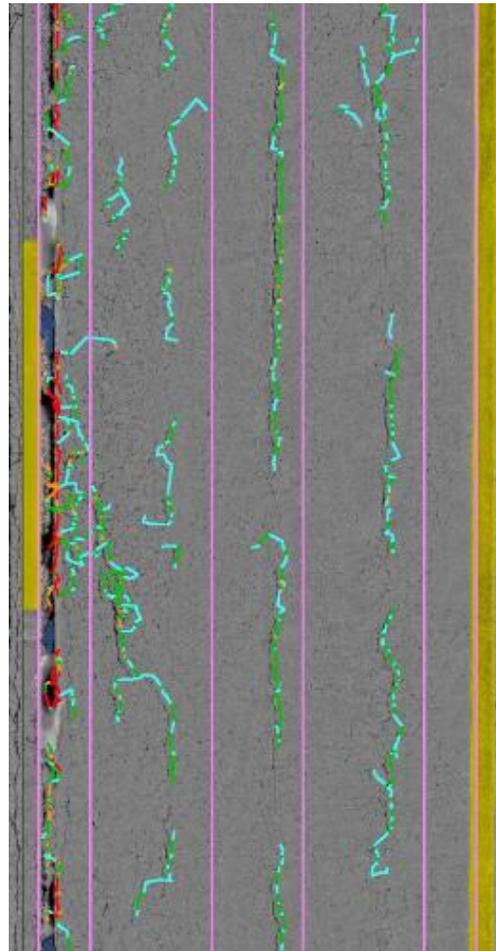
IL 29

Paver Segregation Example

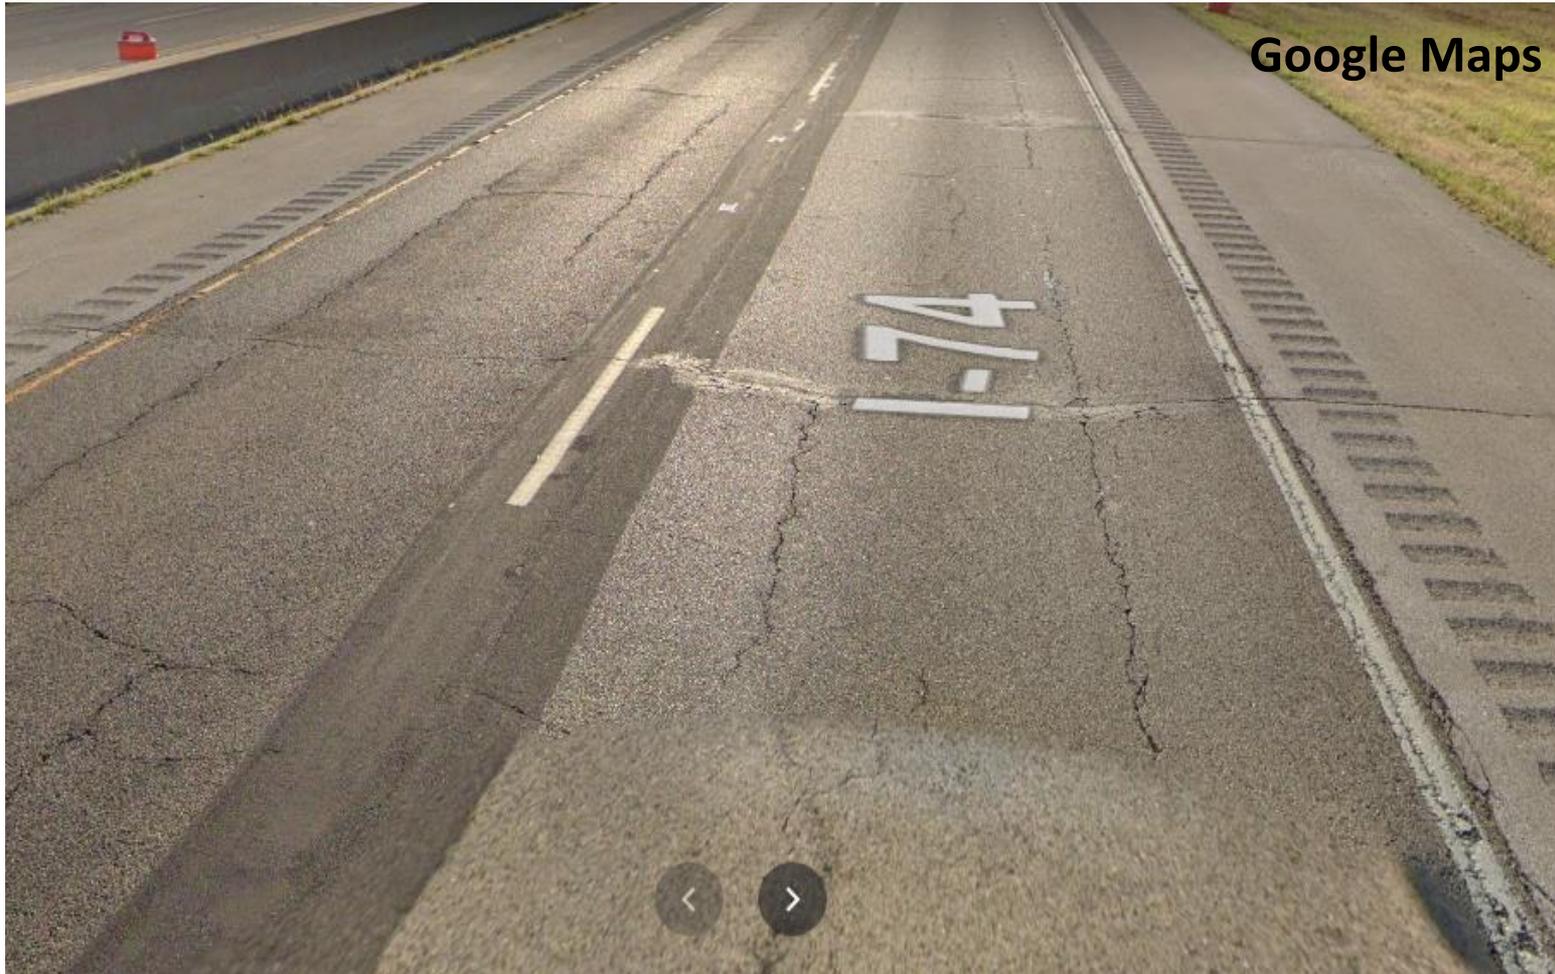
Core Testing

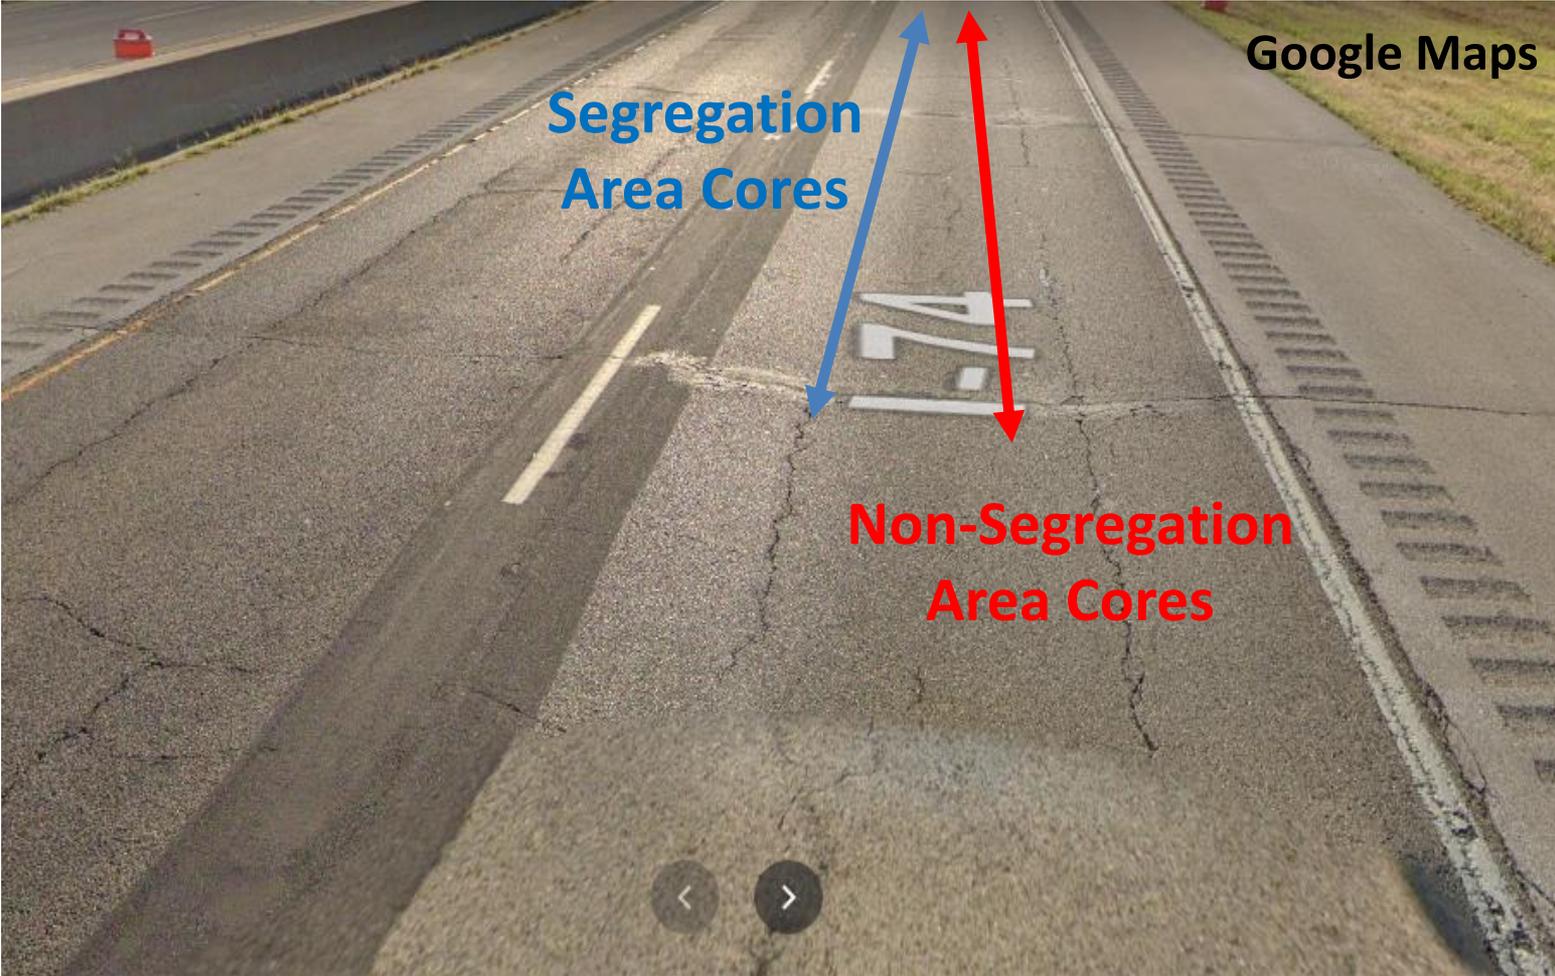
Core Testing

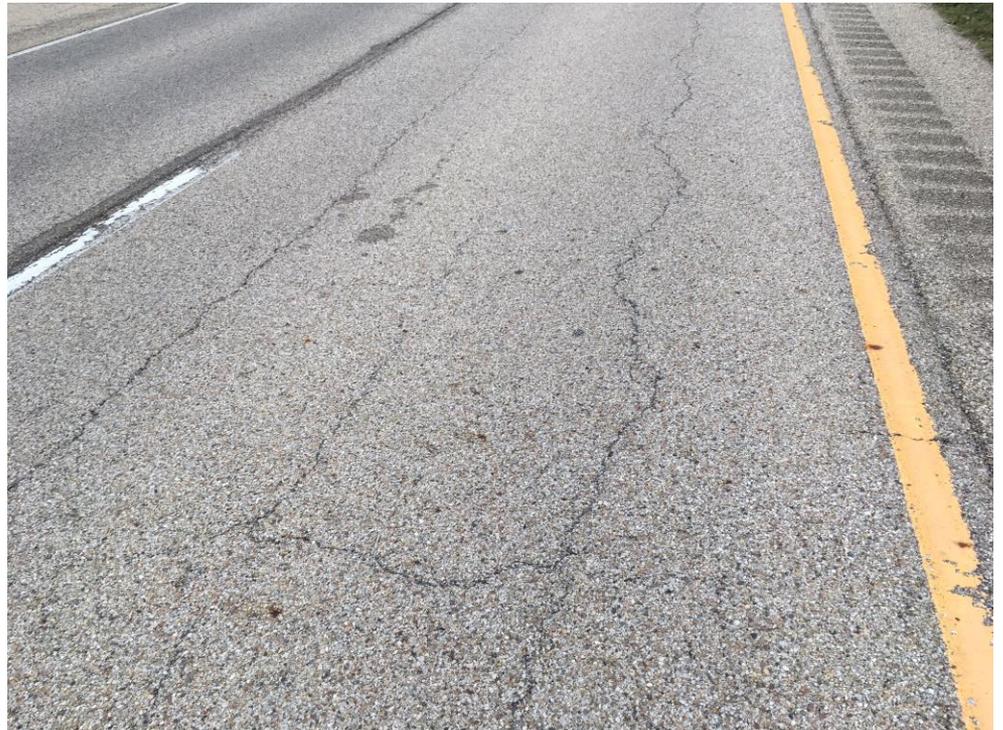
Core Locations

- District 2 - US-30
- District 3 - US-24
- District 4 - I-74
- District 5 - US-36
- District 6 - IL-29
- District 9 - US-51

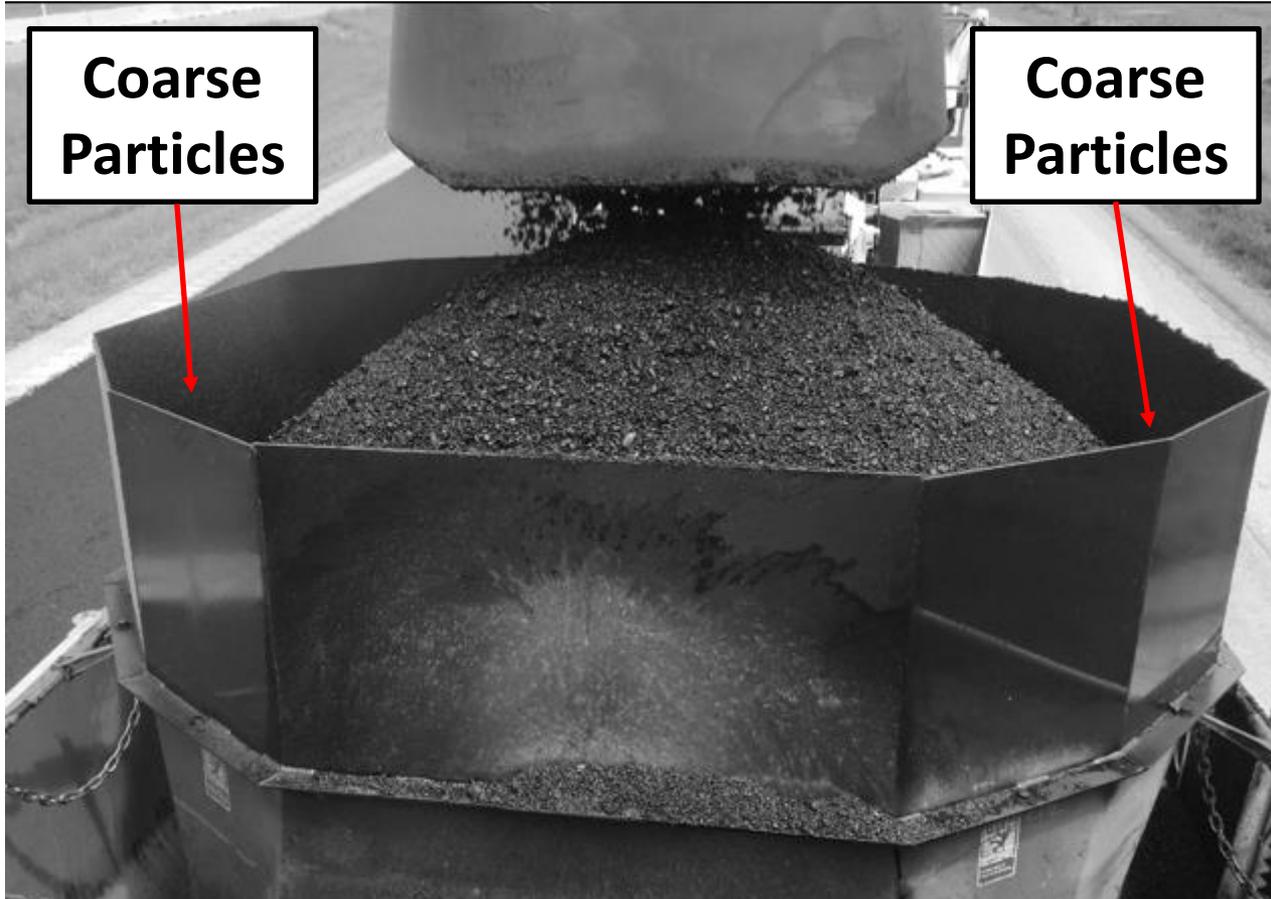
Conical Pile in Paver Hopper Insert

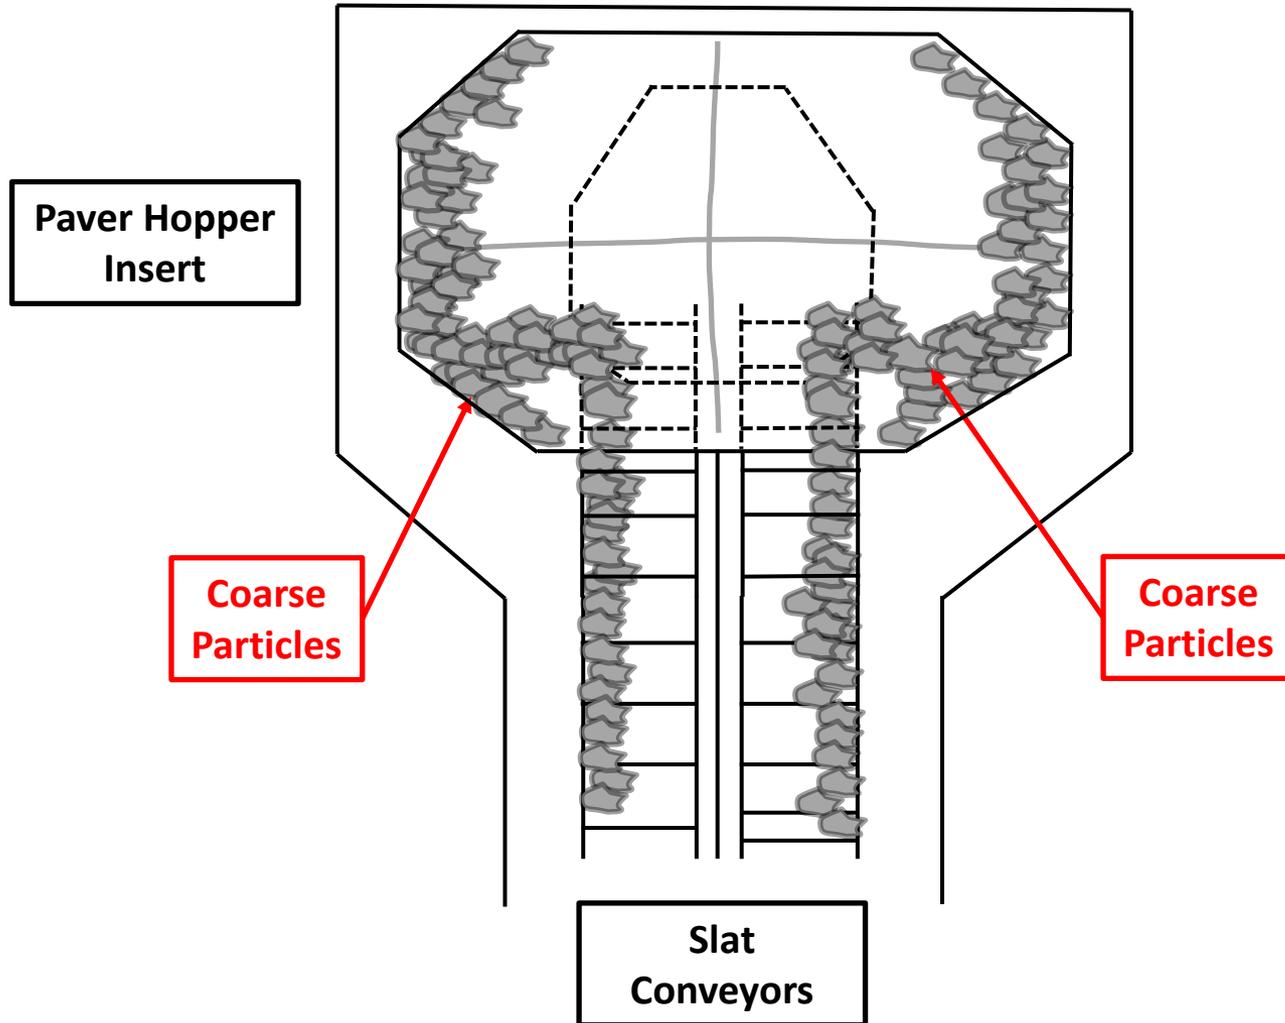
Coarse Particle Movement in Paver Hopper Insert

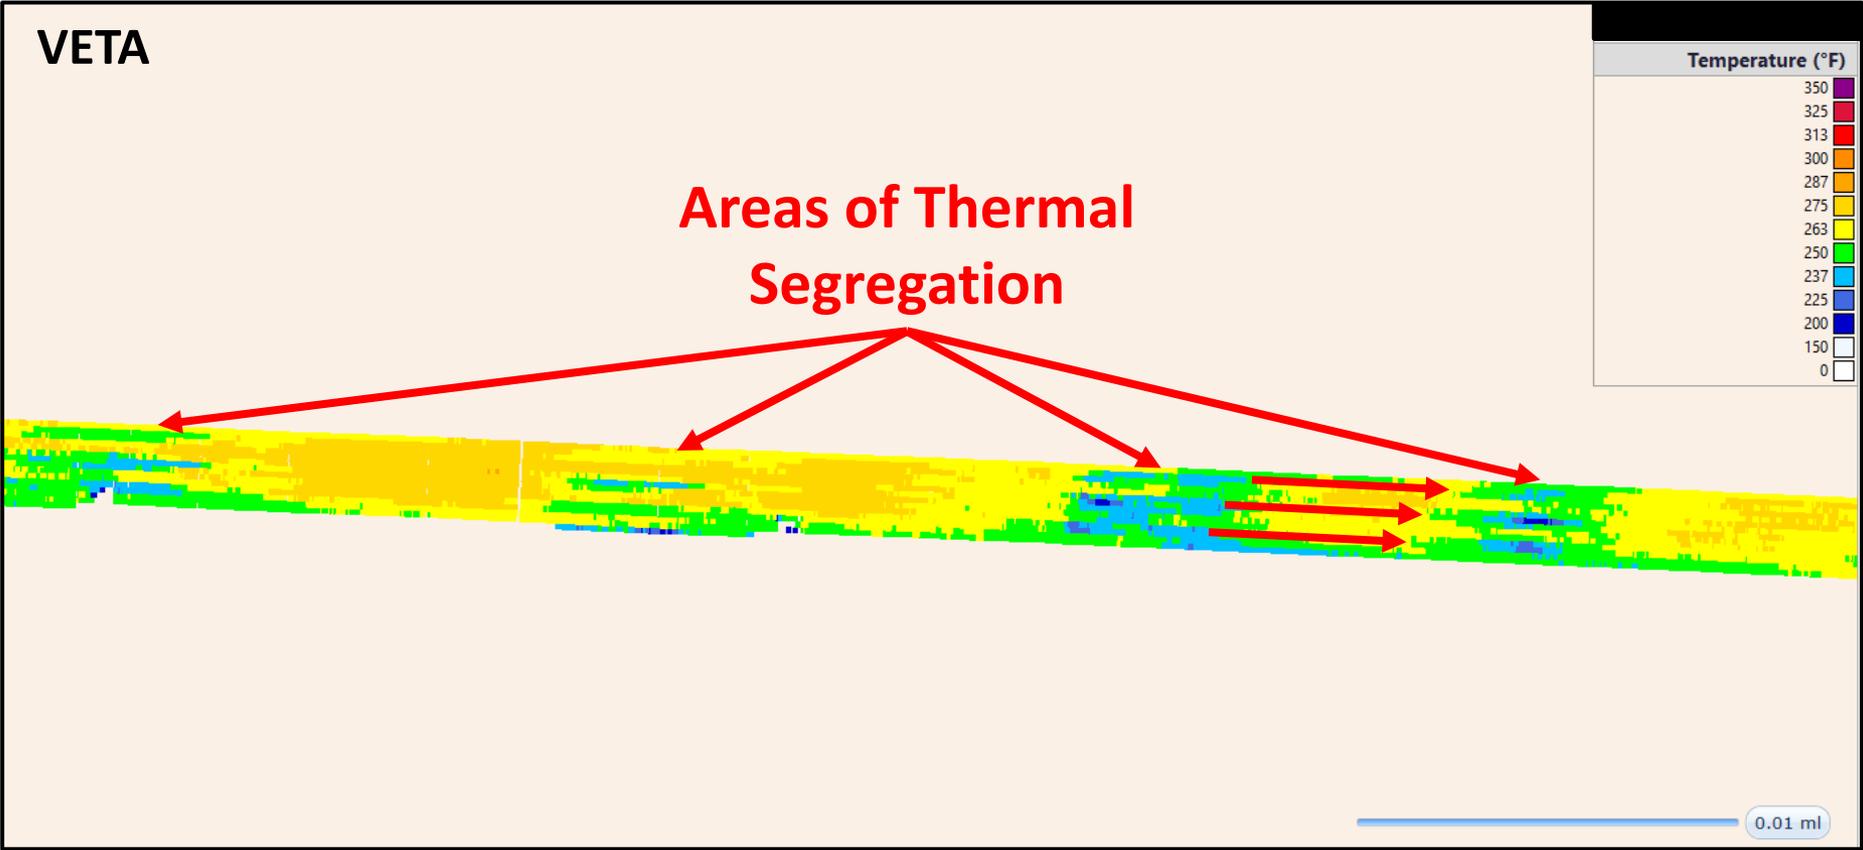
Paver Mounted Thermal Camera Example

- **Winter Paver Evaluations/Meetings**
 - Equipment Suppliers/Contractors/Department
- **Contractor Modifications**
- **Use of Thermal Measurement Technology**
 - Paver Mounted or Handheld Thermal Cameras
