Lab Evaluation of Tollway SMA Surface Mixes With Varied ABR Levels

Steve Gillen
Illinois Tollway

Illinois Asphalt Pavement Association

March 14, 2016

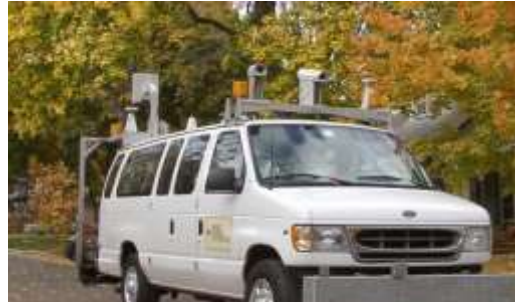
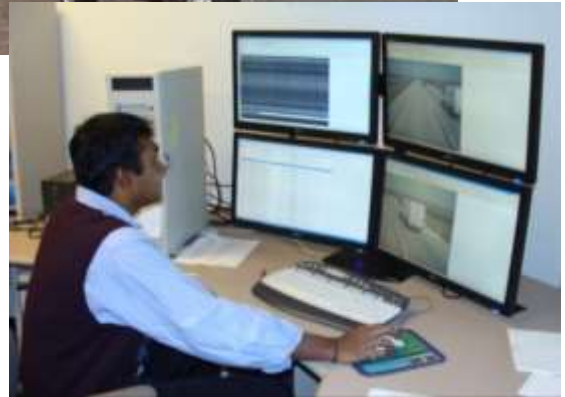
- A pavement management program is of the utmost importance for a large transportation agency
- ARA maintains annual roadway maintenance and rehabilitation records and digital image recordings of the Tollway's pavements and system assets
- All pavement and asset rating occurs in a safe, secure office environment.

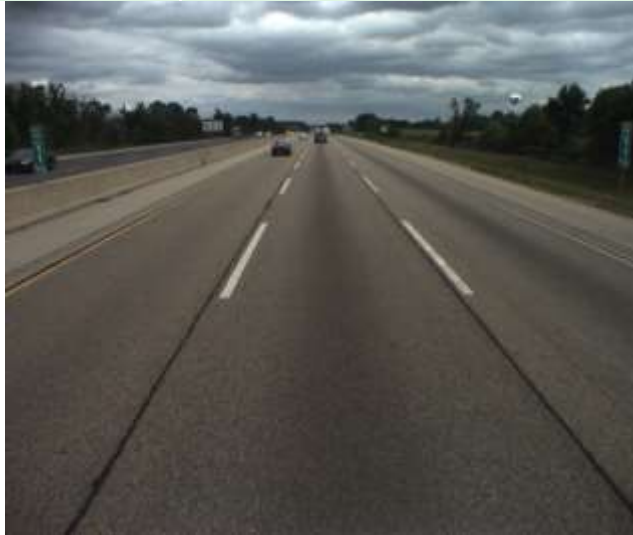
A. I-90 WB Near Rockford (SMA w/ 14% ABR, Built in 2009)

CRS	RSL	Distress Observed
8.1 at core 8.0 for section	15 years	Low to medium centerline cracking/separation, isolated longitudinal cracking, isolated patching (truck fire location and WIM failure only)

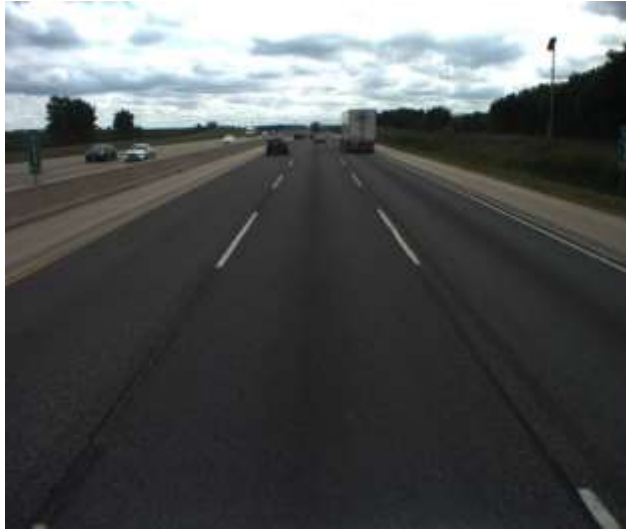
B. I-90 EB Near Rockford (SMA w/ 16% ABR, Built in 2008)

CRS	RSL	Distress Observed
7.8 at core 7.9 for section	12 years	Low to medium centerline cracking/separation, isolated longitudinal cracking

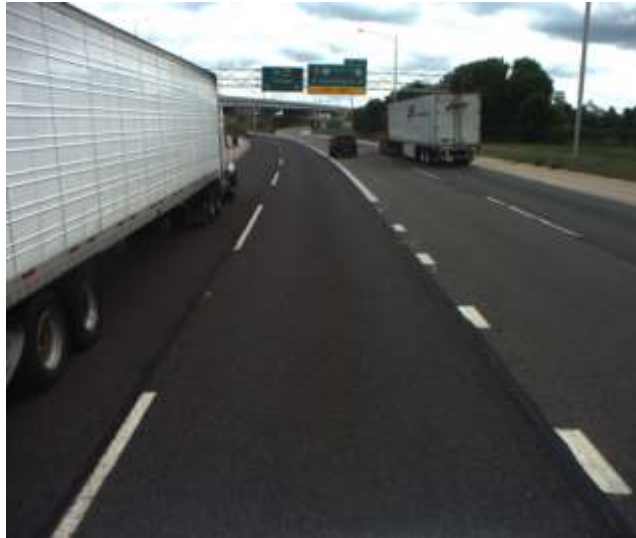
C. I-90 EB South of Rockford Near Newberg (SMA w/ 36% ABR, with RAS, Built in 2009)

CRS	RSL	Distress Observed
7.7 at core 8.1 for section	11 years	Low to medium centerline cracking/separation and isolated transverse cracking

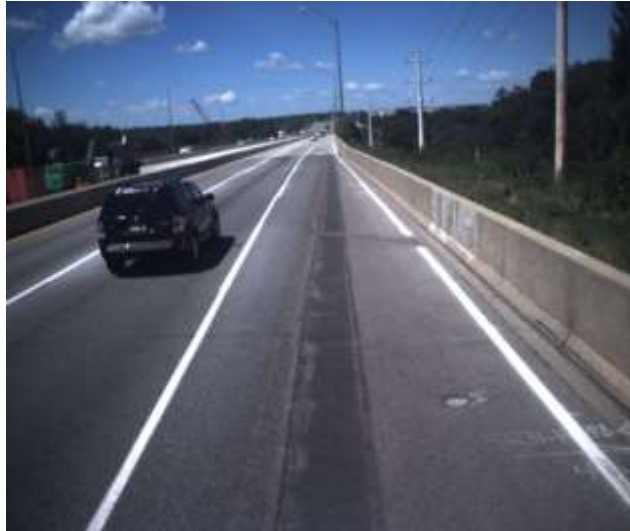
D. I-90 WB Near Rt. 25 in Elgin (SMA w/ 33% ABR, with RAS, Built in 2011)

CRS	RSL	Distress Observed
7.2 at core in 2014	9 years	Low to medium centerline cracking/separation and frequent transverse reflective cracking

2014 Photo

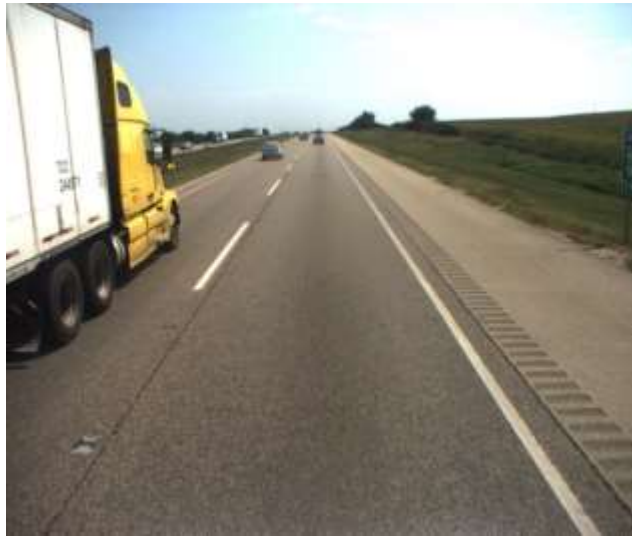
E. I-88 EB East of DeKalb (SMA w/ 37% ABR, Built in 2012)

CRS	RSL	Distress Observed
7.5 at core 7.8 for section	7 years	Low to medium centerline cracking/separation, transverse reflective, and longitudinal cracking

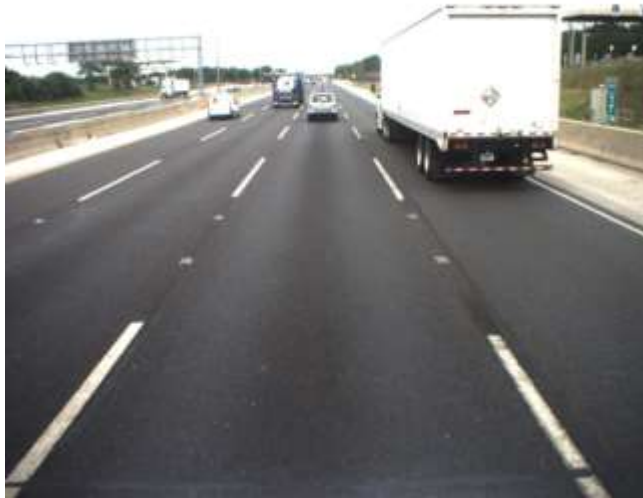
F. I-355 NB at 63rd St. (SMA w/ 0% ABR, Built in 2009)

CRS	RSL	Distress Observed
7.1 at core 7.3 for section	10 years	Low centerline deterioration, frequent transverse reflective cracking of medium to high severity

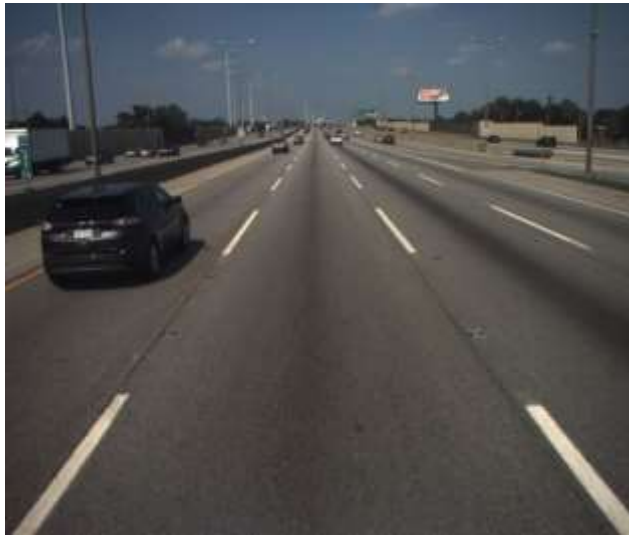
G. I-294 NB North of Cermak Toll Plaza (SMA w/ 31% ABR, Built in 2012)

CRS	RSL	Distress Observed
6.5 at core 6.9 for section	5 years	Frequent transverse reflective cracking of medium severity, low to medium centerline and longitudinal cracking

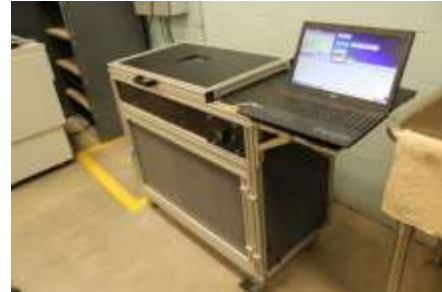
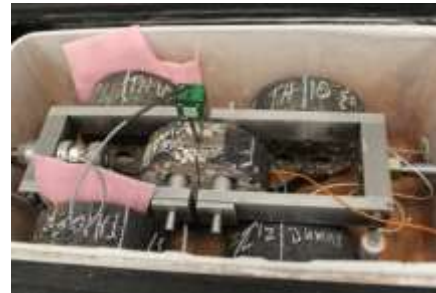
DC(T) Testing

- **ASTM D7313**
- **Assesses low temperature mix performance, i.e., resistance against:**
 - Thermal cracking
 - Block cracking
- **Gives indicator of reflective crack resistance**

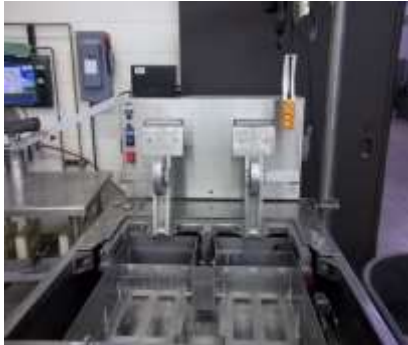
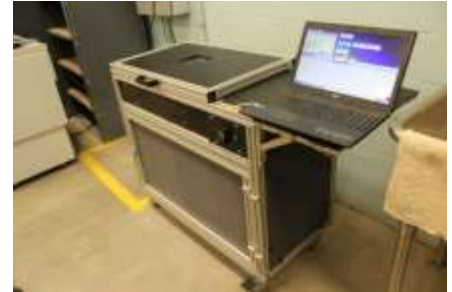
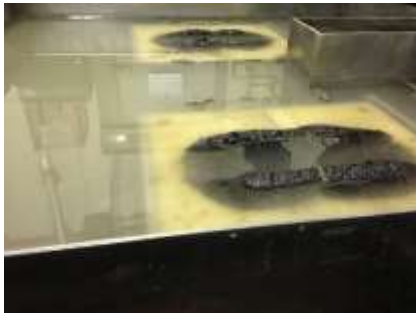
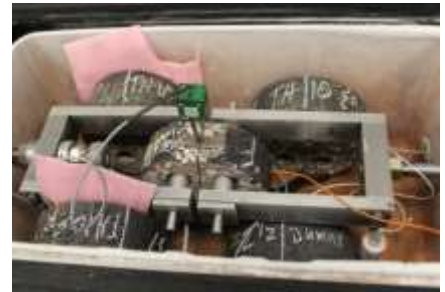
Bracketing Performance

Hamburg

DC(T)
