EXTENDED LIFE HOT MIX ASPHALT PAVEMENT (ELHMAP) TEST SECTIONS AT ATREL

Research Report FHWA-ICT-08-017

ICT-R39 Validation of Design Concepts for Extended Life Hot Mix Asphalt Pavements (ELHMAP)

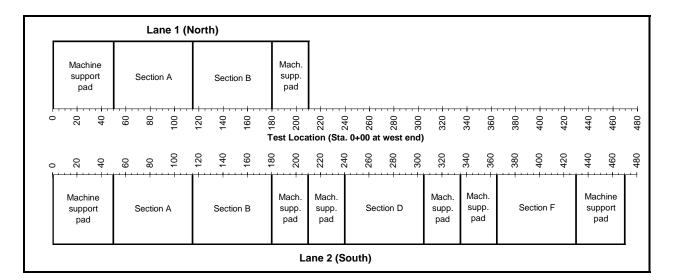
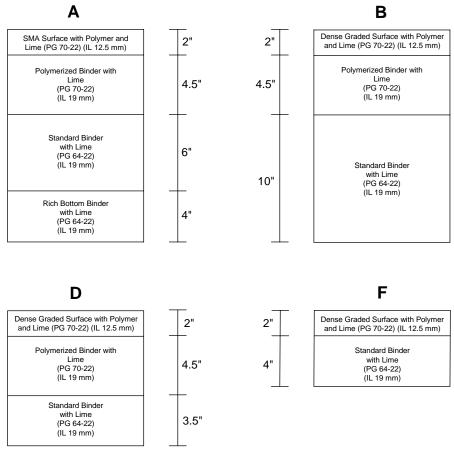
Figure 2. ELHMAP cross sections.

Section A was a 16.5-inch section. The surface was 2 inches of stone matrix asphalt (SMA) over 4.5 inches of polymer-modified binder (PMB), over 6 inches of standard binder (SB), over 4 inches of rich bottom binder mix (RBB) (0.5 percent extra asphalt, compacted to 2-3 percent air voids).

Section B was a 16.5-inch section. The surface was 2 inches of dense graded surface (DGS) mix over 4.5 inches of PMB, over 10 inches of SB.

Section D was an intermediate 10-inch section with 2 inches of DGS over 4.5 inches of PMB mix, over 3.5 inches of SB mix.

Section F was a thin section used for fatigue testing to failure and was 2 inches of DGS mix over 4 inches of SB mix.

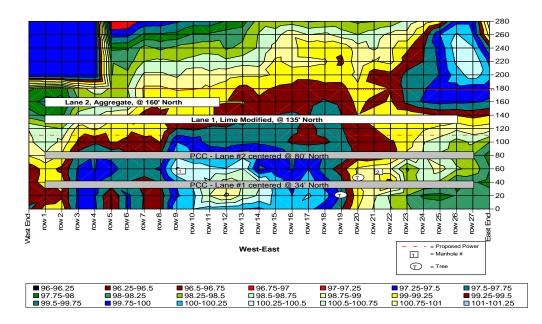
Figure 3. Topographic map of ELHMAP construction site.

Figure 3 shows the project site and layout for the ELHMAP sections at ATREL indicating the topography of the site and the relative location of the ELHMAP sections to the existing CRCP sections.

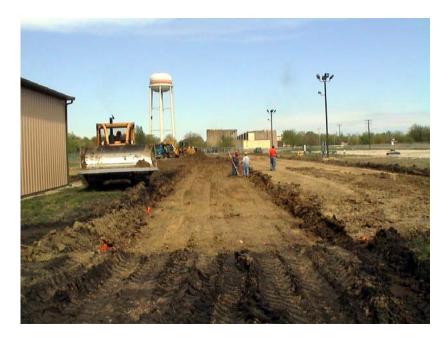
Figure 5. Lanes with topsoil removed.

Site preparation consisted of stripping the topsoil to a consistent depth that would allow the lime-modified subgrade and the aggregate subbase to be at the same final elevation prior to final asphalt paving. The site stripped of top soil is shown in Figure 5.

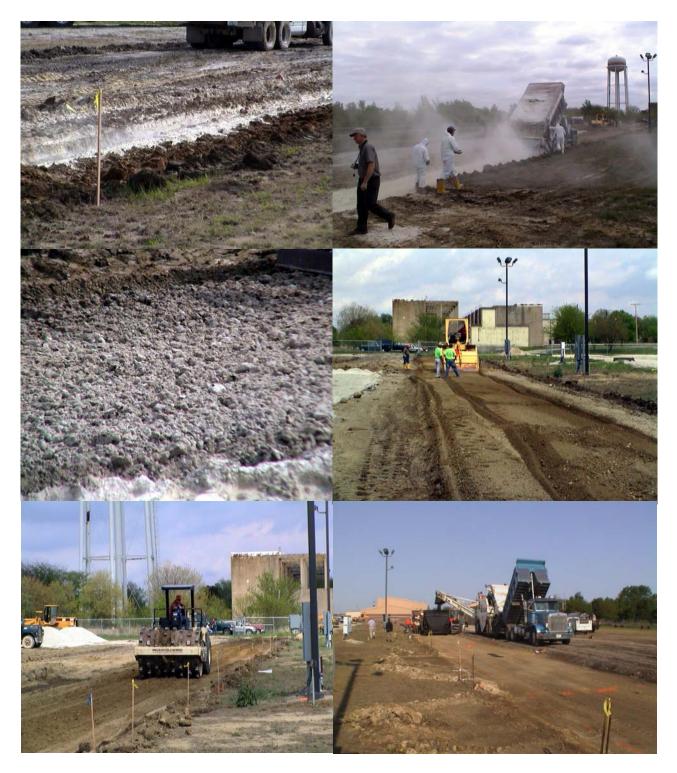
Figure 6. Construction of the lime-modified lane.

Following the stripping activity, Lane 1 (the South lane) was modified with lime. Approximately 2 - 3 percent lime was added, and moisture was added to maintain optimum moisture content during compaction and curing. Figure 6 presents the construction sequence for the lime modification process. The lime was spread with a spreader and mixed with a Bomag pulvimixer to a depth of approximately 12 inches.

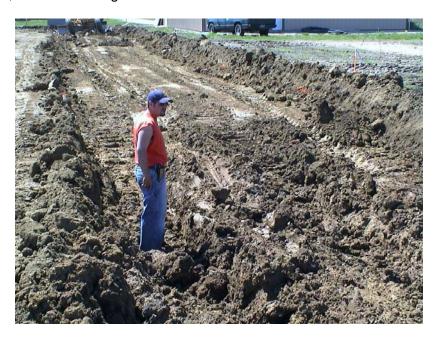
Figure 7. Undercutting at soft spot in Lane 1, aggregate lane.

Lane 2, the North lane, received a compacted aggregate subbase approximately 12 inches thick. During the top soil stripping process, an extremely weak silt layer was encountered in this lane. This soft material was removed and backfilled with aggregate. The undercutting at this location is shown in Figure 7. This location is under a machine support pad, and not in a testing section. The aggregate construction is shown in Figure 8. Following construction of the aggregate subbase, one location was noted where the underlying subgrade had been pumped through the aggregate during compaction, leaving unstable spots. This location was removed, extra aggregate added, and the location was re-compacted, as shown in Figure 9.

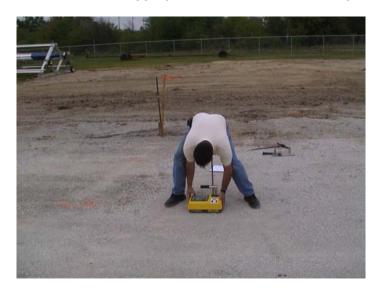
Figure 10. Nuclear density test on reconstructed aggregate subbase.

Following completion of the aggregate subbase, the density was checked using an approved nuclear density gauge by ERI, an engineering testing firm in Savoy, Illinois. Table 5 gives the density data, indicating that the density is satisfactory for a CA-6 even though an ELHMAP pavement structure has no density requirement for the aggregate subbase. Location 1 was in the reconstructed aggregate section, as shown in Figure 10.

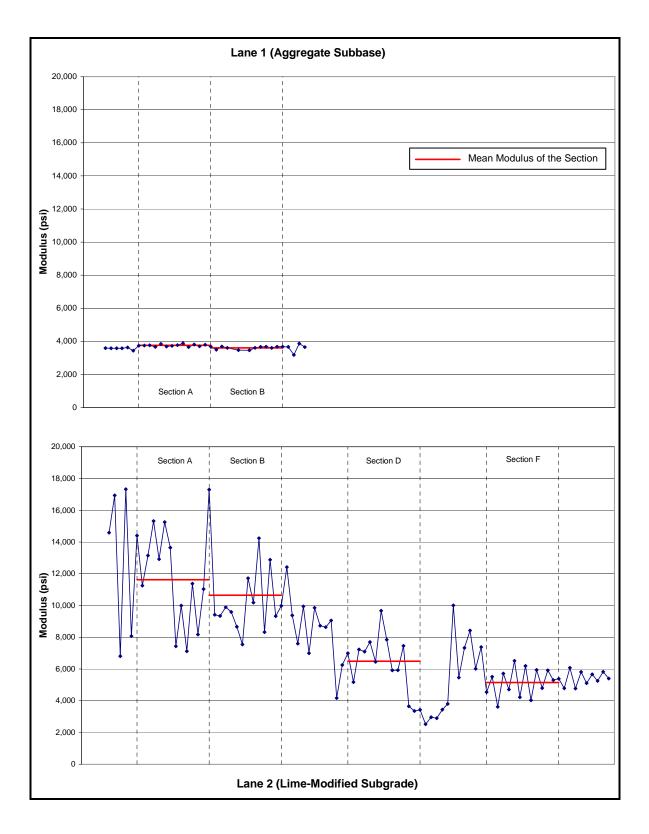
Figure 11. Modulus profiles from FWD testing on finished grade.

Figure 11 shows the profiles of the modulus obtained in both lanes. The mean modulus of the aggregate subbase and the coefficient of variation (COV) are given in Table 6 for each section in Lane 1. Table 7 shows the mean modulus and COV of the lime-modified subgrade obtained for each section in Lane 2. The COV is the mean divided by the standard deviation, expressed as a percent.

The COV is much lower for the aggregate subbase, indicative of the prepared nature of the compacted aggregate. The composite moduli of the lime-modified lane are significantly higher than the aggregate lane, indicating the impact of lime-modification on soils with high clay content relative to aggregate subbase. The COV of the lime-modified sections is more typical of what is found in naturally occurring soils.

These plots of CBR with depth clearly show the differences between the two construction procedures. Lane 1 shows the aggregate subbase with high CBR over low CBR natural grade with a relatively distinct break between the two materials. Lane 2, Sections A and B show a similar trend with the lime modified subgrade having high CBR values and being underlain with lower CBR natural soil below the 12-inch depth. Sections D and F do not show the same high CBR in the lime-modified soil, which could be the result of a construction sequence (inadequate mixing, insufficient water, inadequate lime addition). These soils clearly demonstrated a significant strength increase with the addition of lime under laboratory conditions. This trend in lower field strengths is also seen in the modulus plots (see Figure 11), which show Sections D and F having lower modulus values.

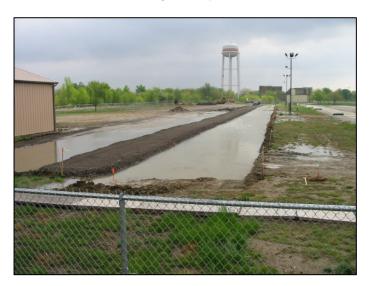
Figure 18. Project site following rain storm.

Following construction of the aggregate subbase and lime-modified subgrade, but prior to the FWD and ADCP testing program, Rantoul experienced a severe thunderstorm which put both lanes under water, as shown in Figure 18. This ponding of water is typical of the drainage characteristics of these natural soils in Illinois. The site was dewatered with portable sump pumps the morning after the rain, as shown in Figure 19. No adverse effects were observed from this short-term submergence of the grades, and the test data certainly indicate no strength loss due to the soaking activity.

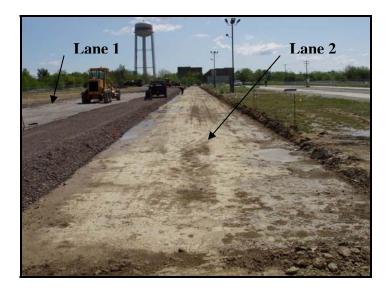
Figure 19. Project site following dewatering.

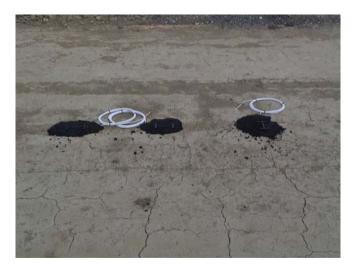
Figure 22. Placement of strain gauges.

After completing subgrade preparation for the lime-modified subgrade and the aggregate subbase, three strain gauges were placed along the centerline of each test section in the approximate center of the section. Two of the gauges were placed laterally, and the third was placed longitudinally as shown in Figure 22. These gauges were first seated in a thin layer of polymer modified mix that was scalped to produce a sand size mix. These gauges were then covered using a thin layer of an asphalt sand mixture to keep the gauges in place during the initial stages of paving.

The reason for using an asphalt sand mixture was to ensure that no large aggregates would be in direct contact with the strain gauge, which would prevent possible breakage of the gauge. The wires of the strain gauges were embedded into a small handmade trench in the top layer of the subgrade and held in place by metal "u-shaped" fasteners to ensure that the wires did not get caught on the paving machine during the initial stages of paving. This initial preparation provided a cool HMA cover to the gauges that prevented movements when fresh HMA was placed and the paving equipment passed for placement and compaction. The strain gauges were checked after construction, and all gauges were functioning.

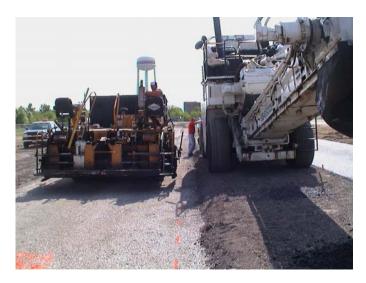
Figure 23. MTD on RAP center lane during paving.

In an attempt to eliminate segregation and mixture variations and prevent aggregate subbase/lime-modified subgrade disturbance from repeated paving operations, a Material Transfer Device (MTD) was specified for these short sections. To accommodate the MTD, the center area between the two pavements was topped with a layer of recycled asphalt pavement (RAP). This RAP material was donated by the city of Rantoul. From this central area, the MTD could directly supply the paver with HMA on either lane. Figure 23 illustrates the RAP center area with the MTD in operation.

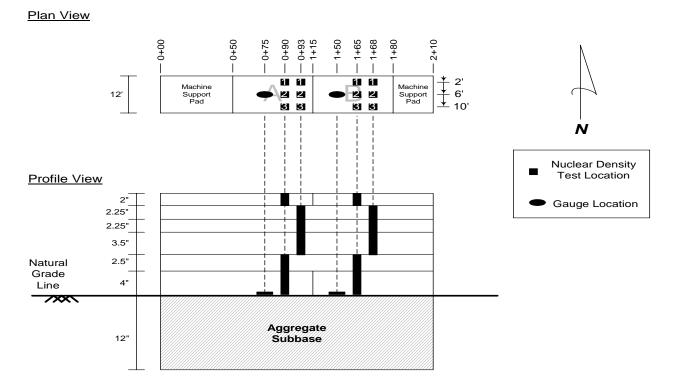
Figure 31. Coring and density locations for Lane 1.

HMA Extended Life Pavement Density Testing and Coring Layout Lane 1

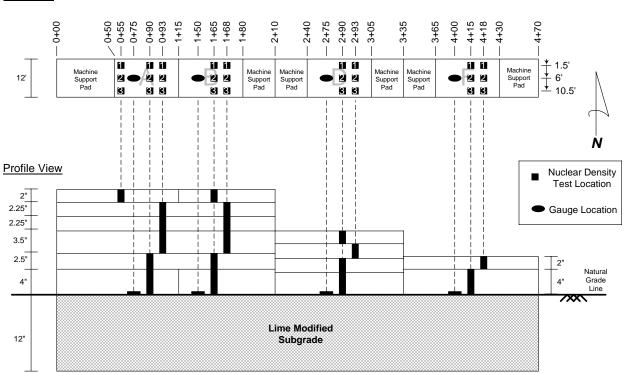
Figure 32. Coring and density locations for Lane 2.

HMA Extended Life Pavement Density Testing and Coring Layout Lane 2

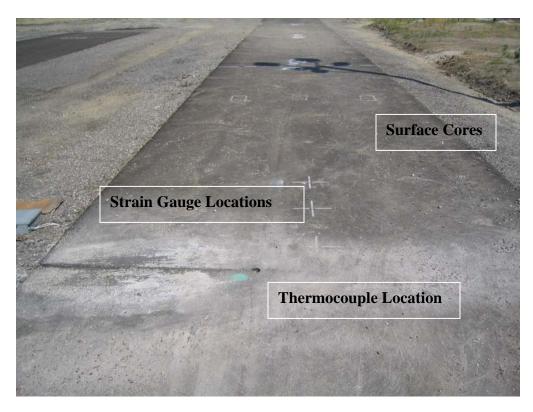
Figure 33. Completed surface showing strain gauge locations, thermocouple location, and core locations relative to strain gauge locations.
