A STUDY TO DELINEATE CIRCUMSTANCES CAUSING RUTTING IN BRAND NEW ASPHALT PAVEMENTS AND DEVELOPING MITIGATION METHODS

Case History- Saluki Drive Pavement, Southern Illinois University Carbondale

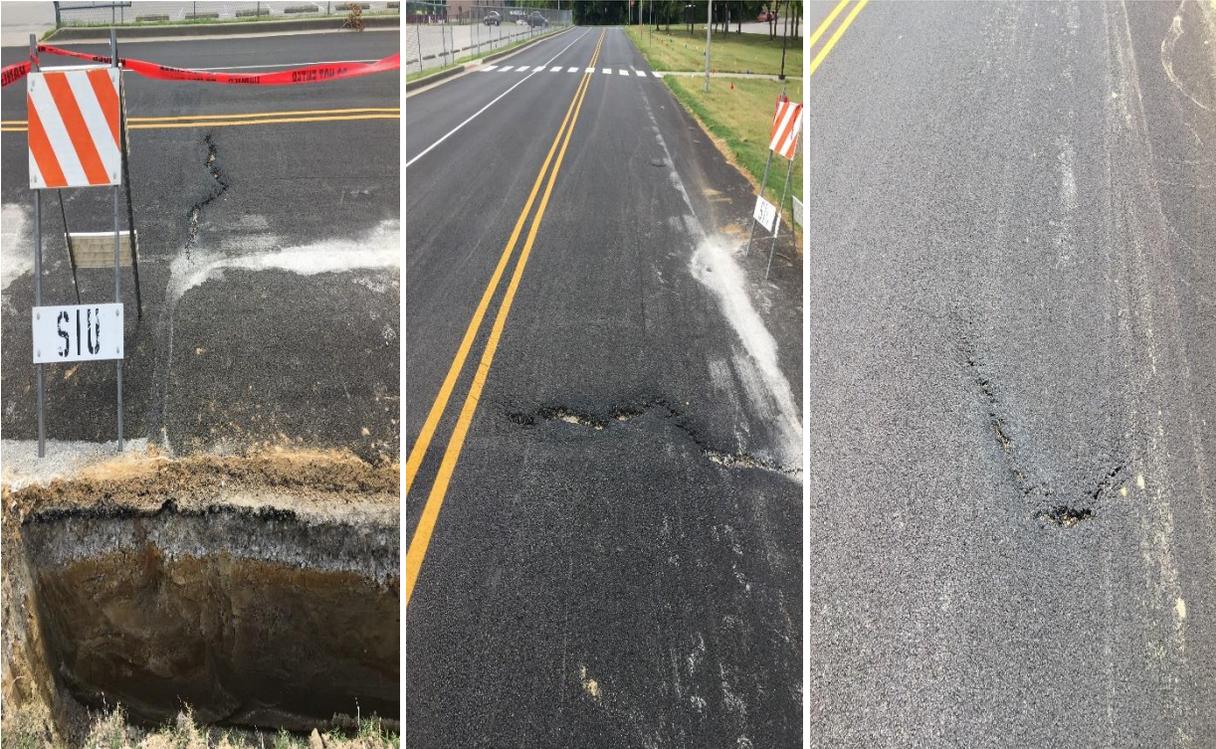
The saluki drive pavement showcased the rutting phenomena, in less than a month from when it was laid. As discussed in the literature, the causes of rutting may depend on various factors, proper investigation and the extent of the issue, can lead to a better solution. The following are the pictures explaining the failure of the pavement.

Fig 3: Rutting of the Saluki Drive Pavement

All these anomalies in the results based on the specifications led to the failure of the pavement.

- The gradation of the aggregates have to be in compliance with the design and have to be less absorptive.
- The temperature of the bitumen and the mix design should be properly checked before mixing.
- Binder course should be more permeable than the surface course.
- Proper drum rolling should be carried out on the pavement to create an effective bonding between the pavement layers.
- Problems encountered in pavements are site specific, and proper understanding of the problem leads to resolving the issue efficiently as well as economically.

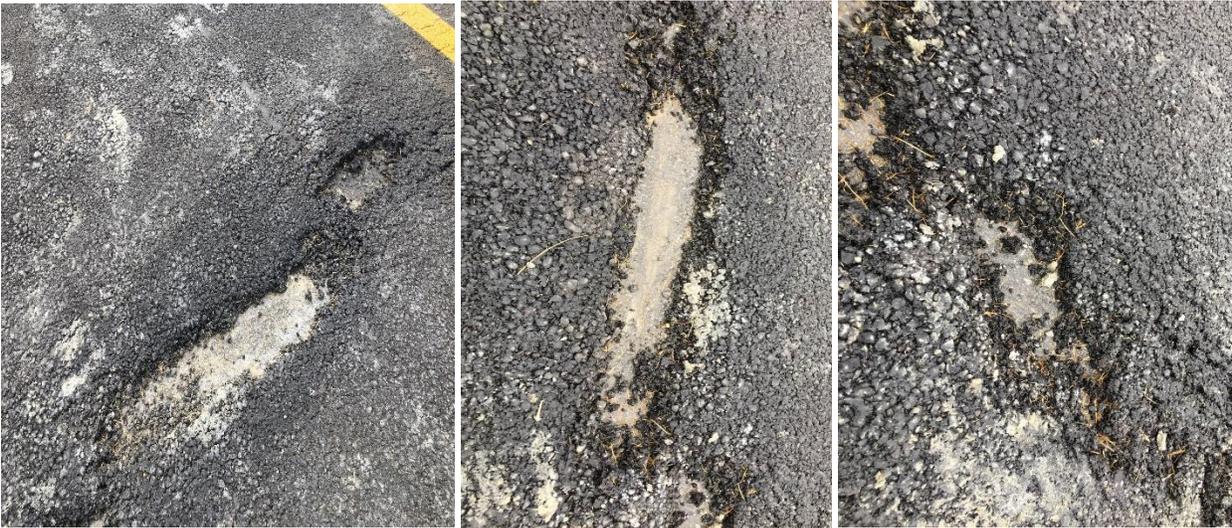
Fig 4: No proper bonding between the layers of the asphalt pavement

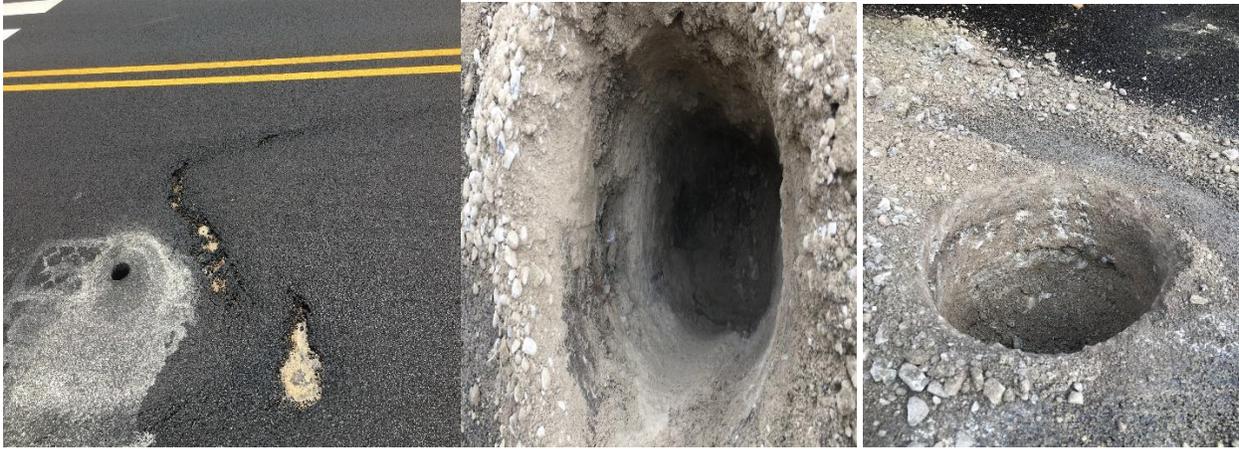
Fig 5: Sample cores drilled at the failure location

The following Table 2, presents the results of the percentage of bitumen content tested from the cores drilled at the failure location, using ignition method. According to IDOT specifications, the bituminous content should range between 4-6%. It can be seen that, all the cores tested do not fall in this range and is another reason for failure.

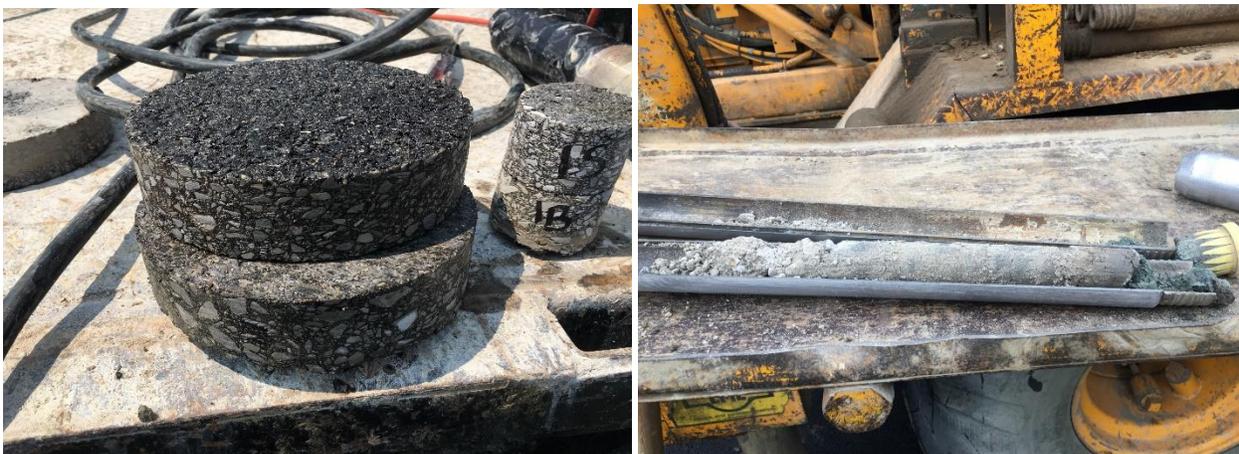
To figure out the reason for the rutting, bond failure, and the water clog on the surface, sample cores were tested for percentage of bitumen and split spoon samples were drilled and collected to see the crushed stone moisture percentage.

Fig 7: Core samples for bitumen content and split spoon sample for crushed stone moisture percentage

The following Table 1, presents the results of crushed stone moisture percentage, by drying the samples in the oven at a regulated temperature. The typical optimum moisture content (OMC) of crushed stone is from 5-7%. It can be clearly seen from our results that none of our moisture percentages fall in the optimum range, and this could be one of the issue for the failure of the saluki drive pavement.
