I-90 / I-39 Full Depth Asphalt – 7 Year Performance

Steve Gillen
Illinois Tollway

Illinois Asphalt Pavement Association

March 9, 2015

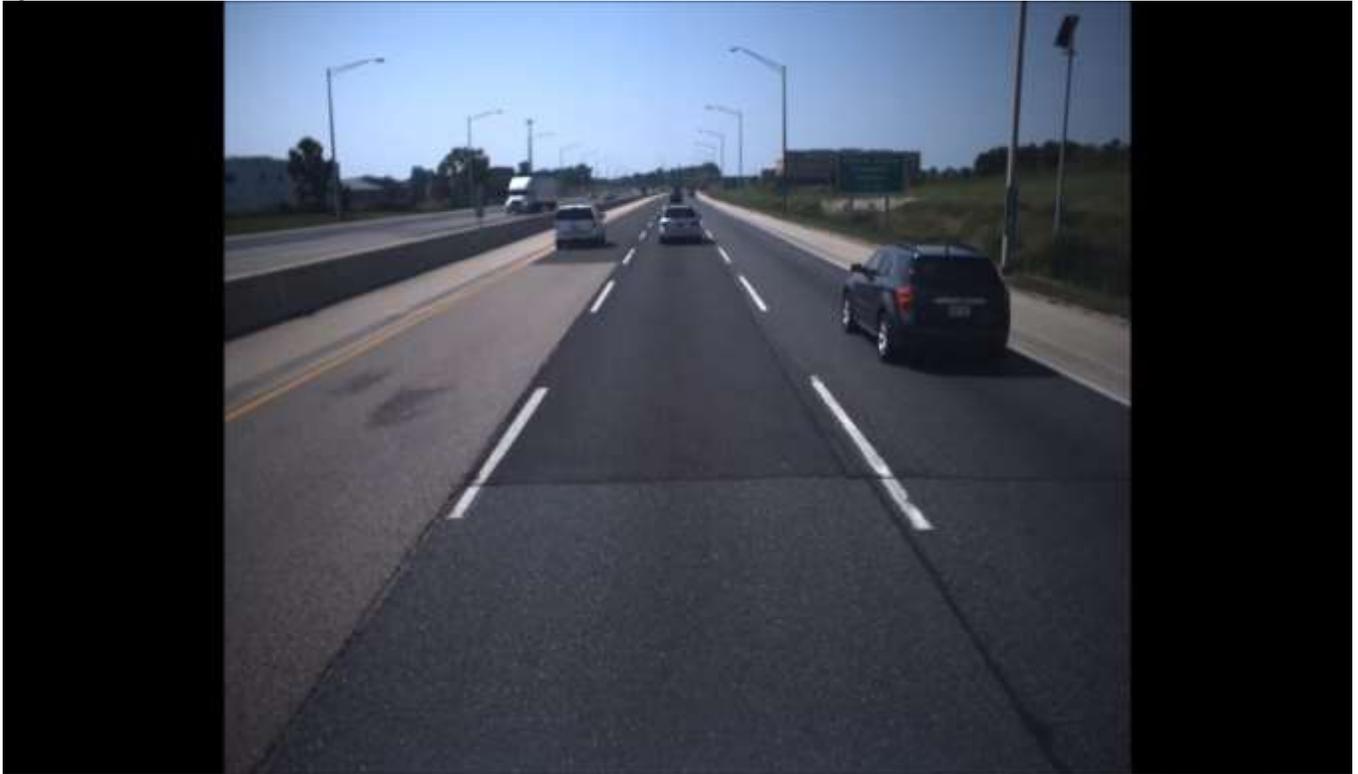
Video: EB I-90 MP 16.5-17.5

Condition of Mainline I-90 Pavements: EB MP 2.5-18

- **Distresses**
 - **Minor transverse and longitudinal cracking**
 - **Minor to moderate longitudinal joint cracking/seam separation**
 - **All longitudinal joints to be routed & sealed in 2015**

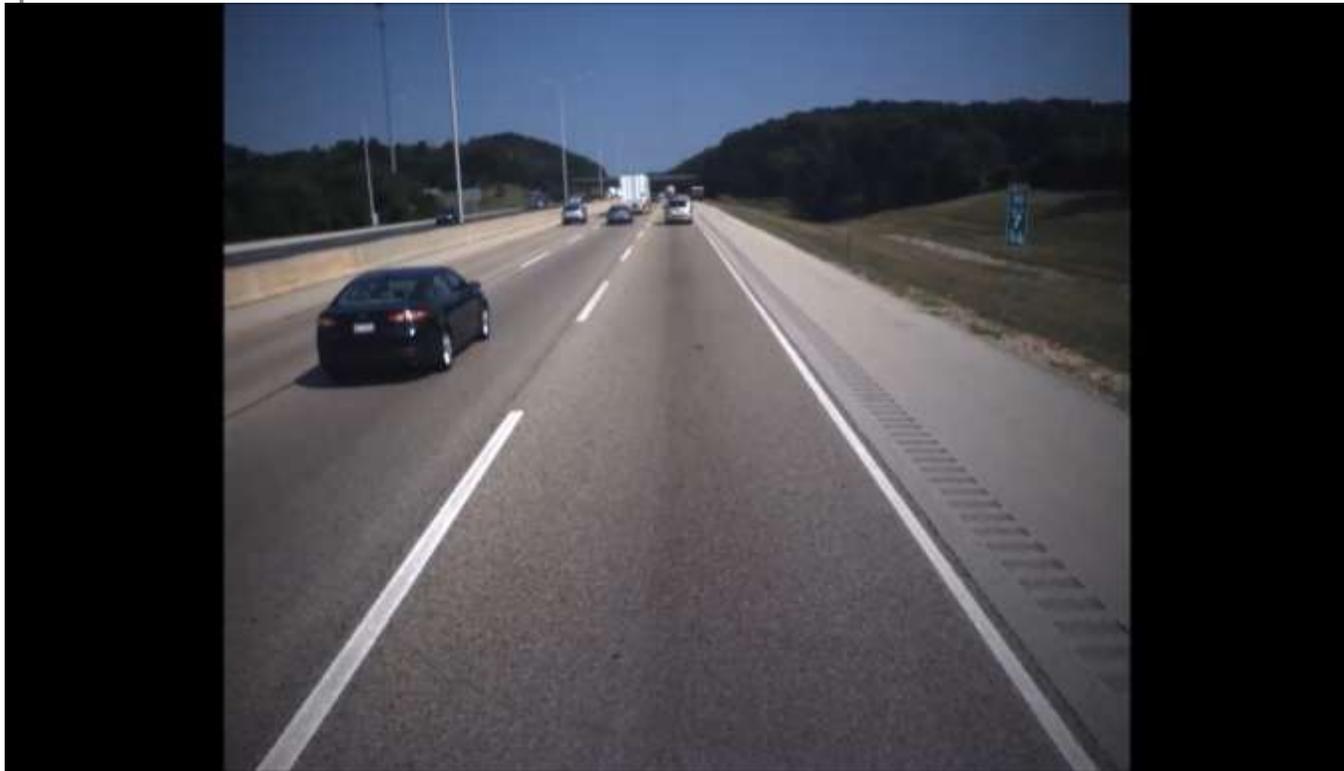
Video: WB I-90 MP 7.75-4.0

Condition of RAS test strips on WB I-90 outside shoulders: MP 7.5-4.0

- Minor but consistent transverse and longitudinal cracking
- Minor to moderate longitudinal joint cracking/spalling

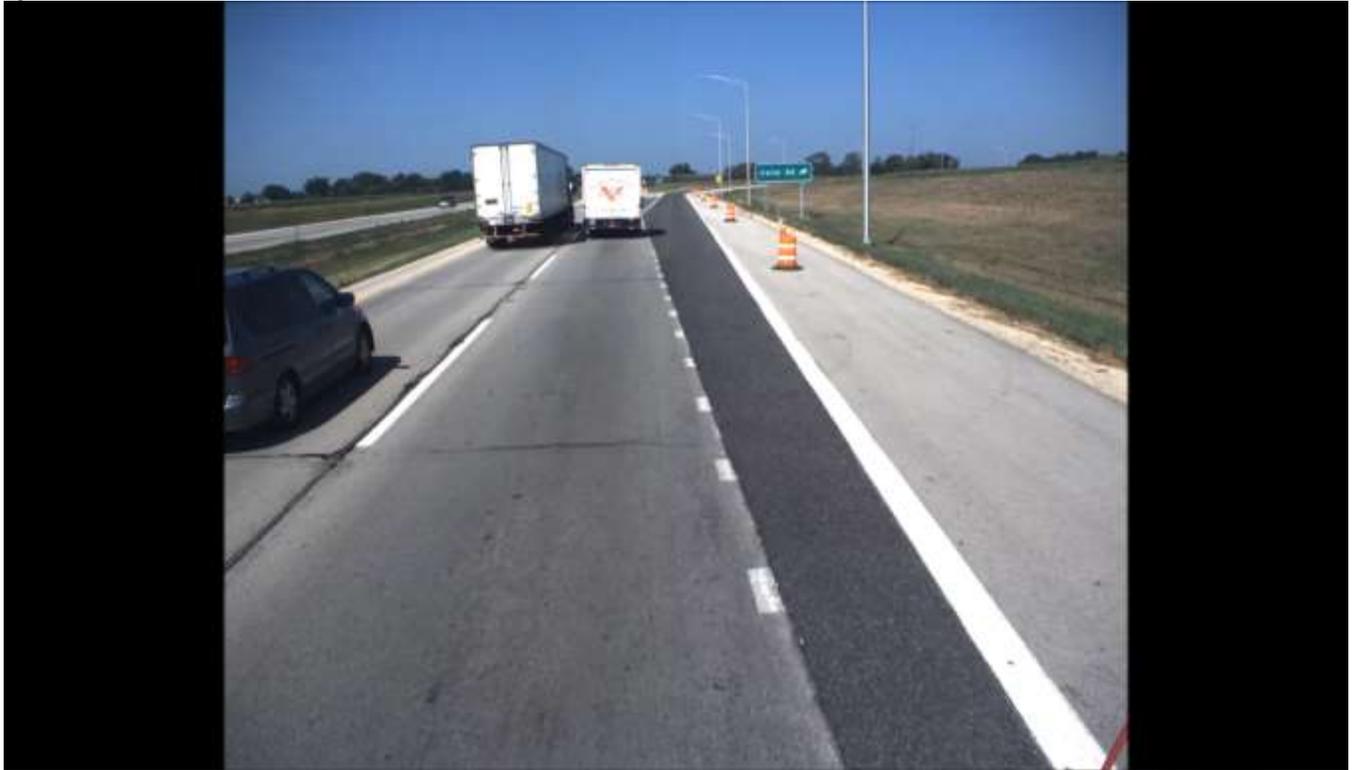
Video: I-90 WB Exit Ramp at Irene Road

Condition of I-90 WB Exit Ramp at Irene Road

- **2009: No visible distresses**
- **2012: Minor longitudinal cracking in a couple of spots**
