# I-70 Extended Life Pavement Performance

Charles Wienrank, P.E.  
Pavement Design Engineer  
IDOT - Bureau of Research

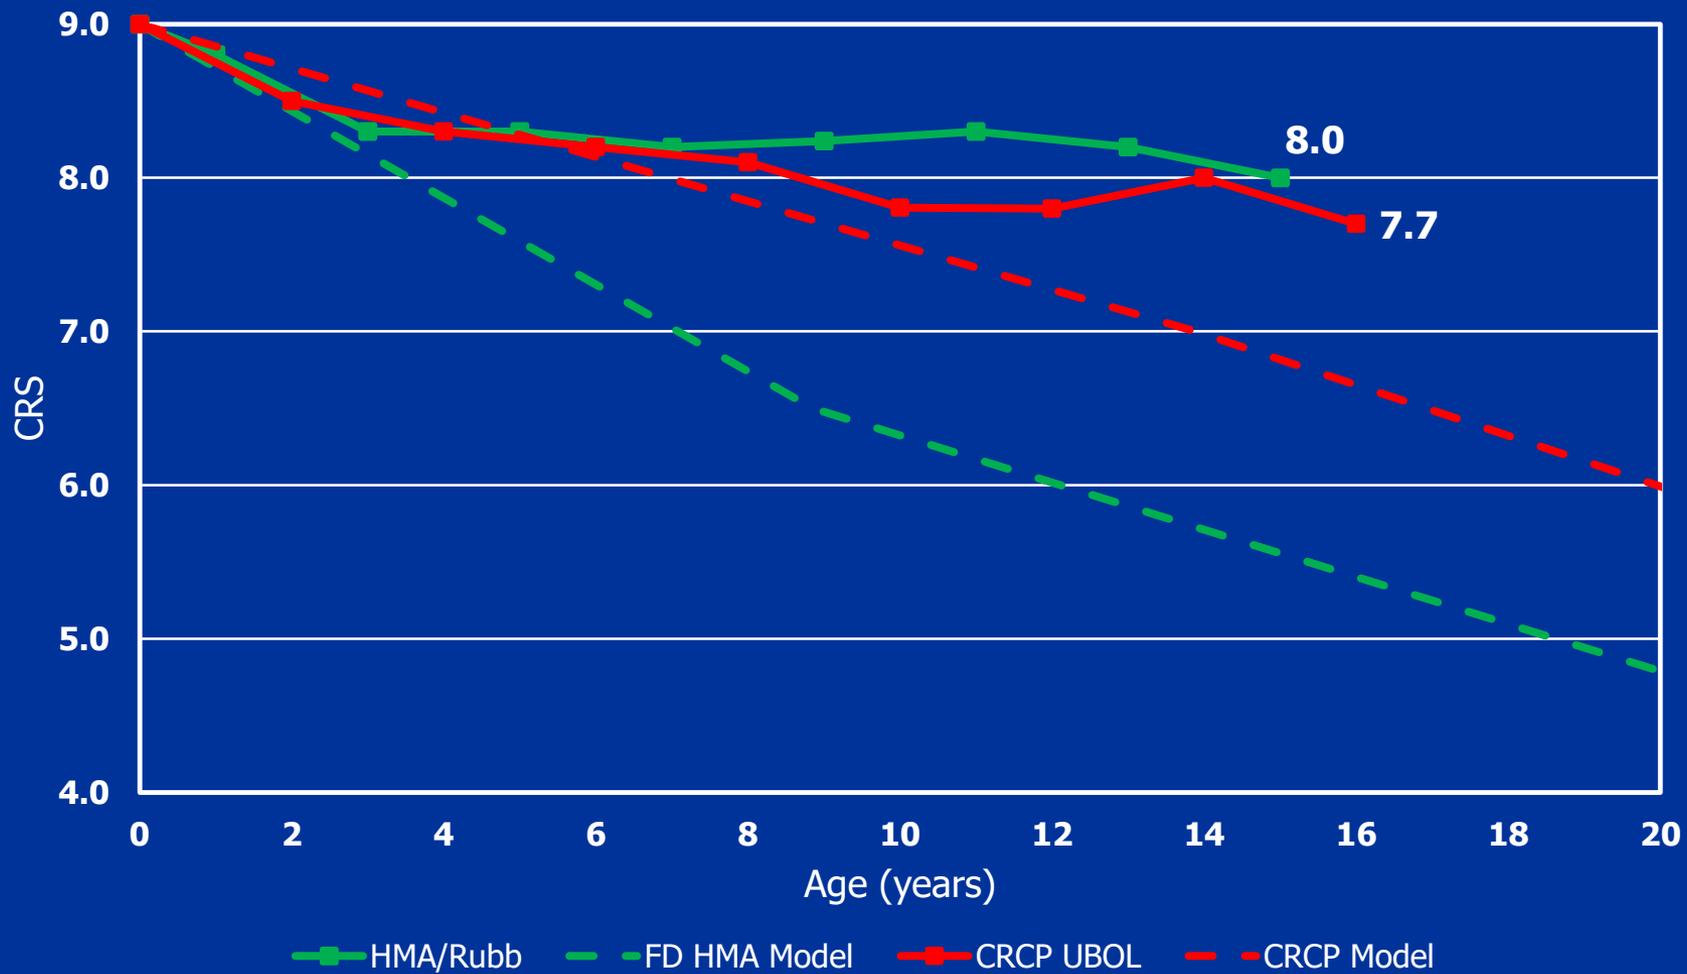
# CRS vs Age

- 2018 CRS=8.0, IRI=48
- Rutting=0.11 in.
- Centerline deterioration is only recorded CRS distress
- No warranty repairs on pavement (some bridge deck repairs)
