INTERSTATE RUBBLIZATION AND STAGE CONSTRUCTION

Ross Bentsen, Tollway Engineering Consultant
March 12, 2024

REAGAN MEMORIAL TOLLWAY (I-88)

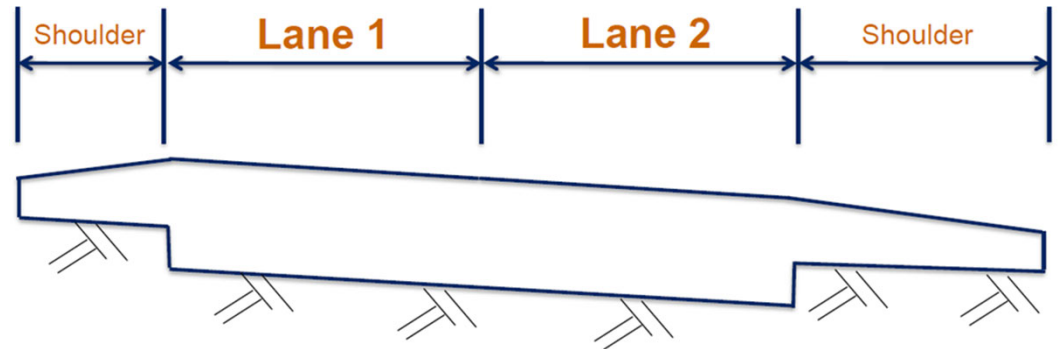
Original cross-section

Original pavement

- Built in 1974
- 14-inch JCP – monolithic pavement over subgrade
- Concrete repairs in 1991
- Asphalt overlay in 1993
- Asphalt repairs in 2001, 2003

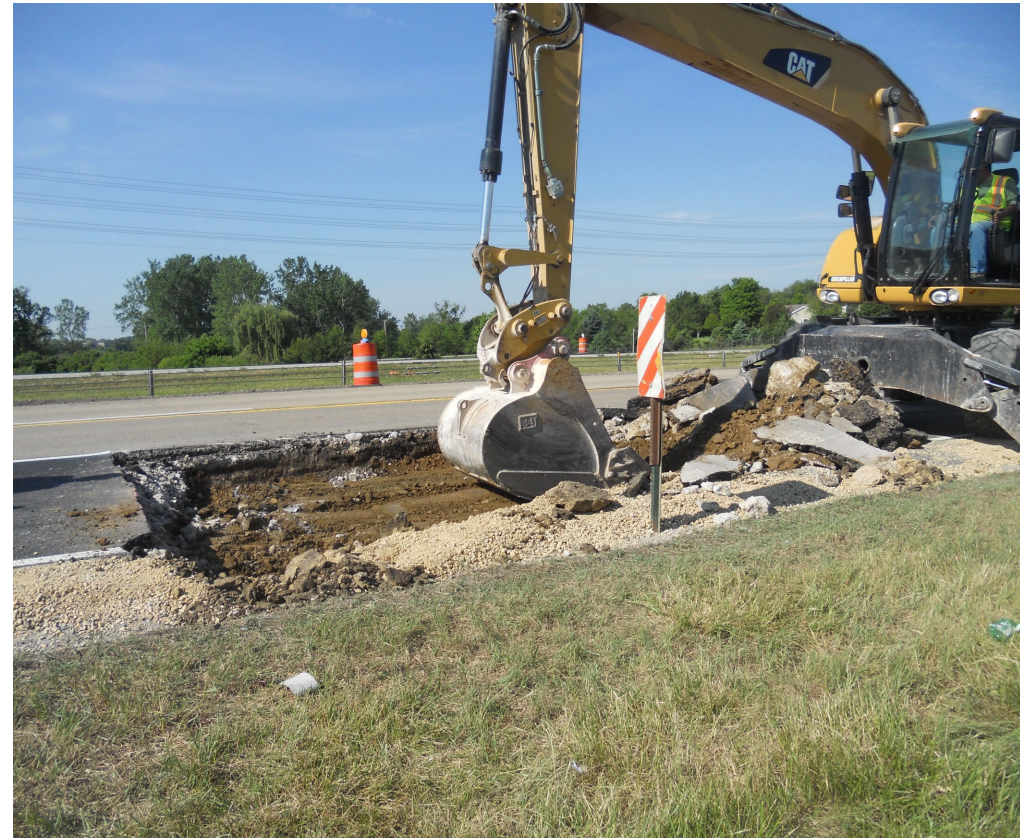
THE REAL ISSUE

Intermittent repairs

Shoulders coming apart

Blow-ups more common

Estimate: Un-maintainable winter

Programmed for mill-overlay in 2007

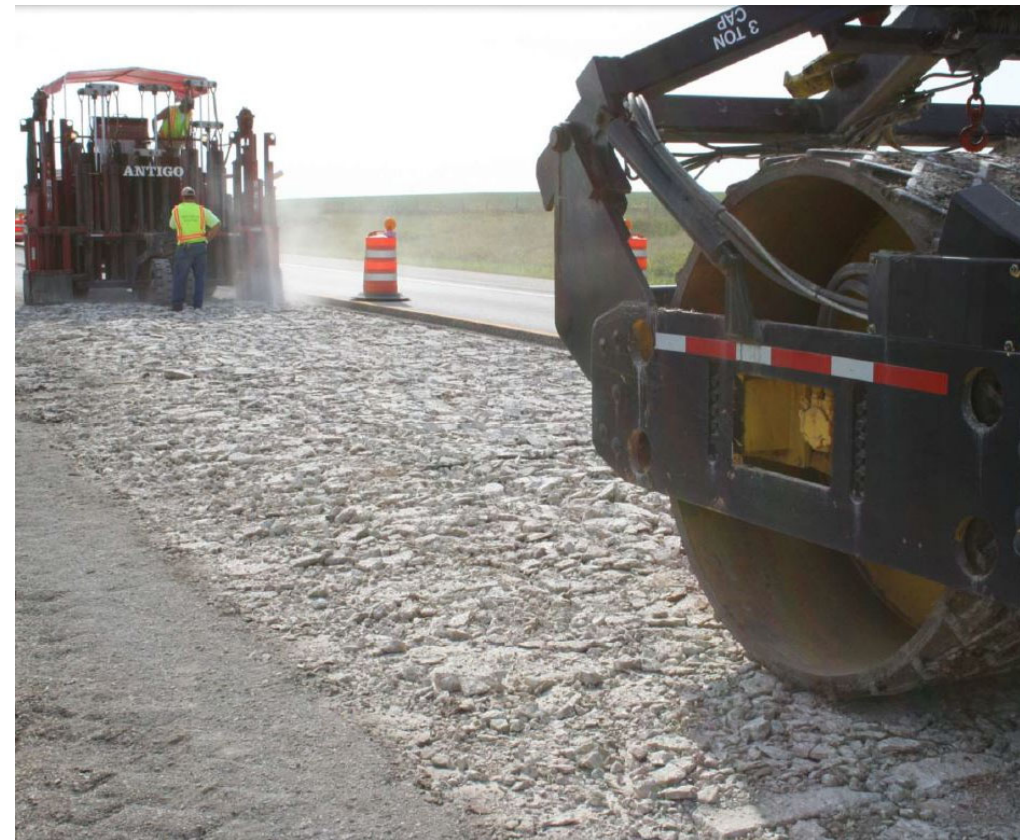
STAGE 1 CONSTRUCTION – 2005

Use up less than 30 percent of fatigue life

Rubblize existing pavement

Install underdrains

6-inch new HMA pavement

- 4-inch dense-graded binder mix with SBS polymer
- 2-inch dense-graded surface mix with SBS polymer
