I-39 HMA Overlay & Rubblization

Experimental Work Plan

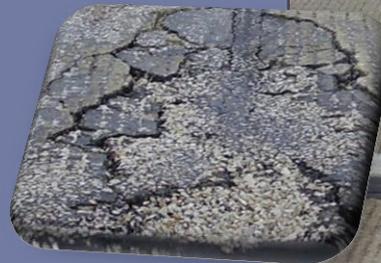
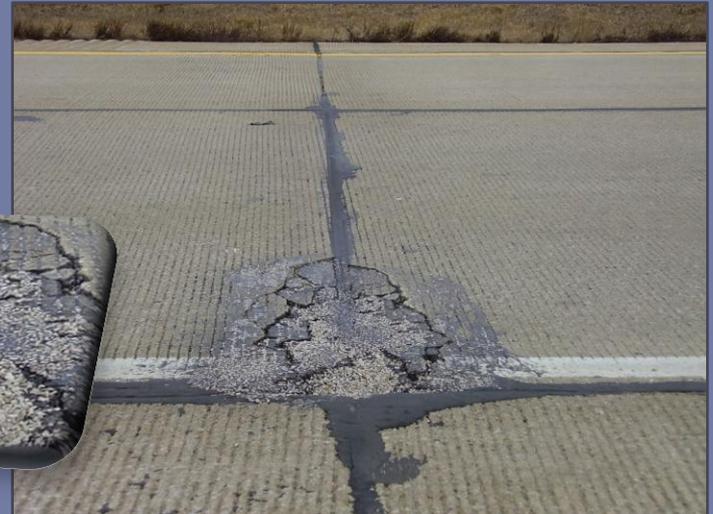
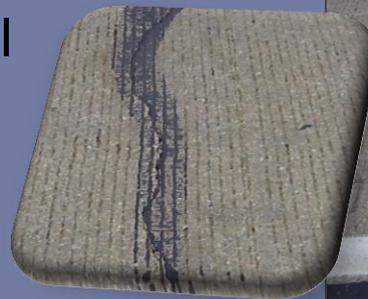
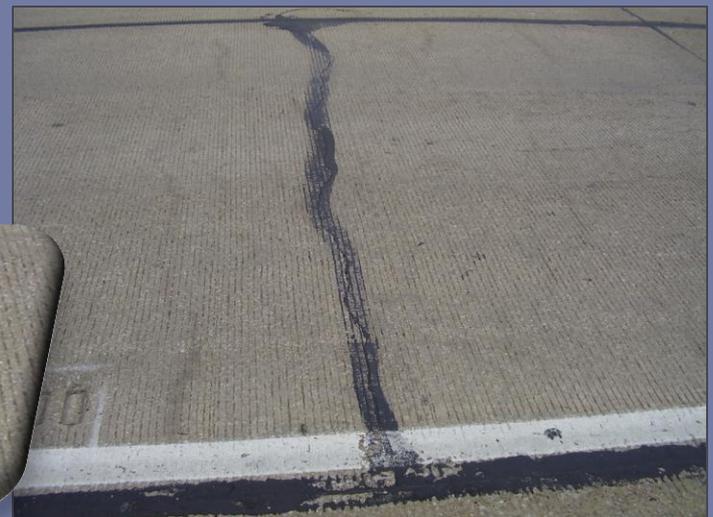
Pavement Distresses

-Durability Cracking

-High Level Infrequent

Transverse Cracking

-Medium to High level

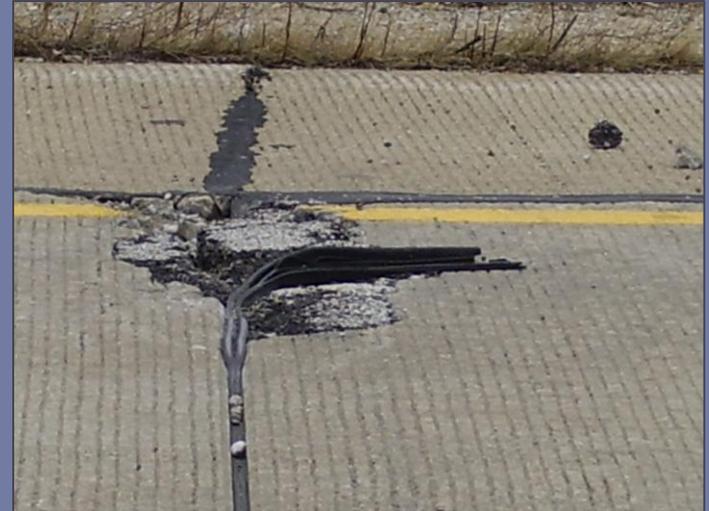
Joint Deterioration

Frequent / Spalling

Greater than 6 inches

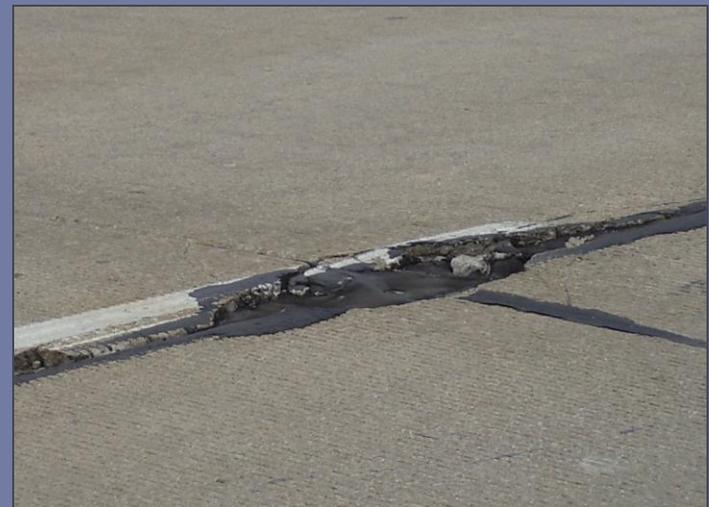
Centerline Deterioration

High Level / Spalling

Greater than 6 inches

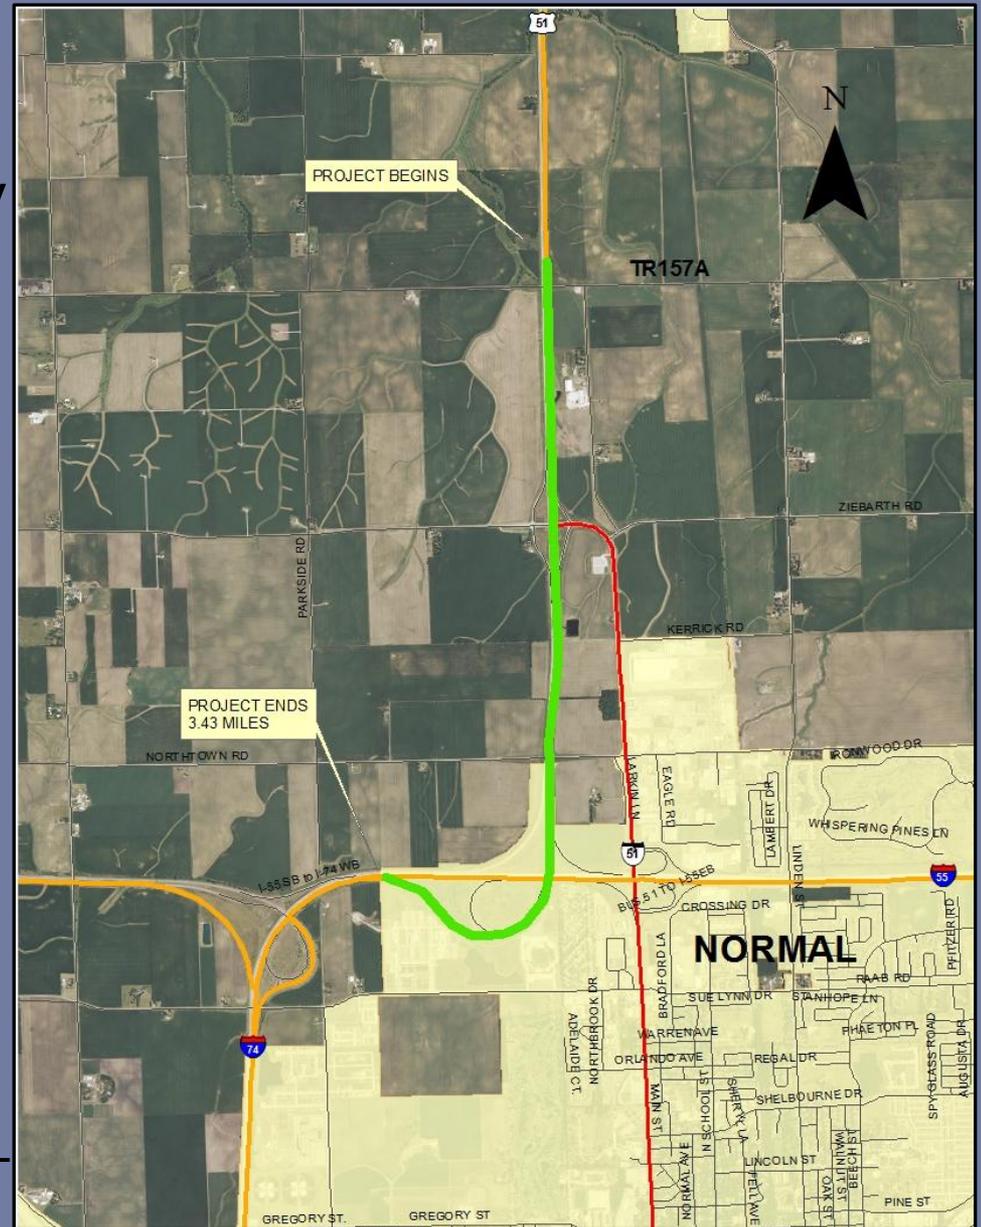
- I-39 from I-55 to N of TR 157A in McLean County

Constructed in 1989

15 ft Hinge Jointed PCC Pavement

10 ¾ inch

Tied PCC shoulders

4-inch Stabilized Sub-base, CAM II

16-inch Processed Lime Modified Soil

19,000 ADT, 28 % Trucks, 33 Million ESAL

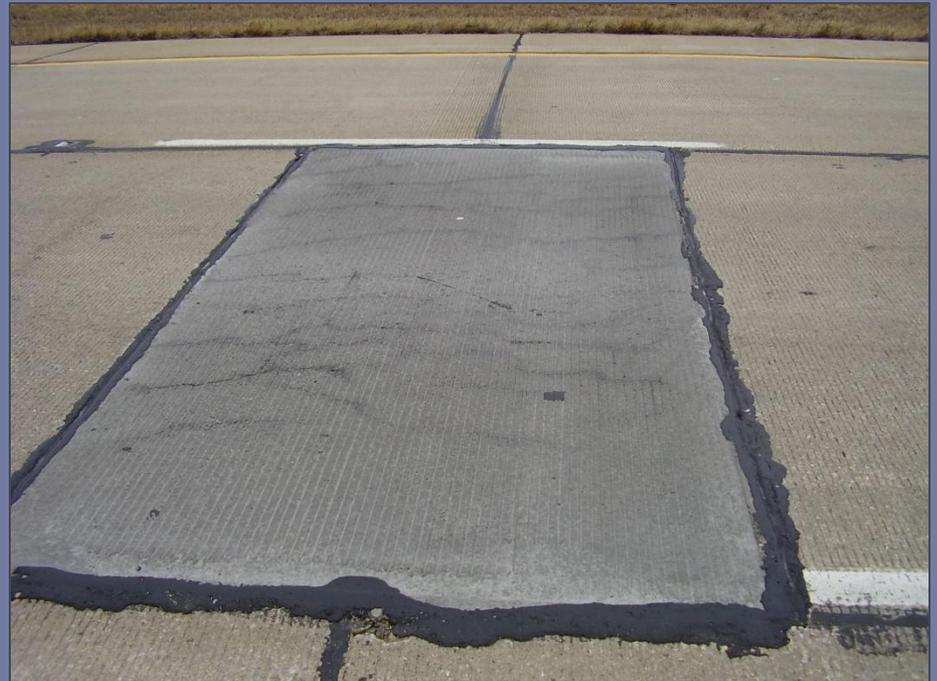
I-39 Patching Survey

Existing Patching

Six Patching Contracts since 2009 totaling \$2,090,000

-10% Total Patching

-Patching concentrated in the driving lanes

New Patching

Estimated 12% Patching

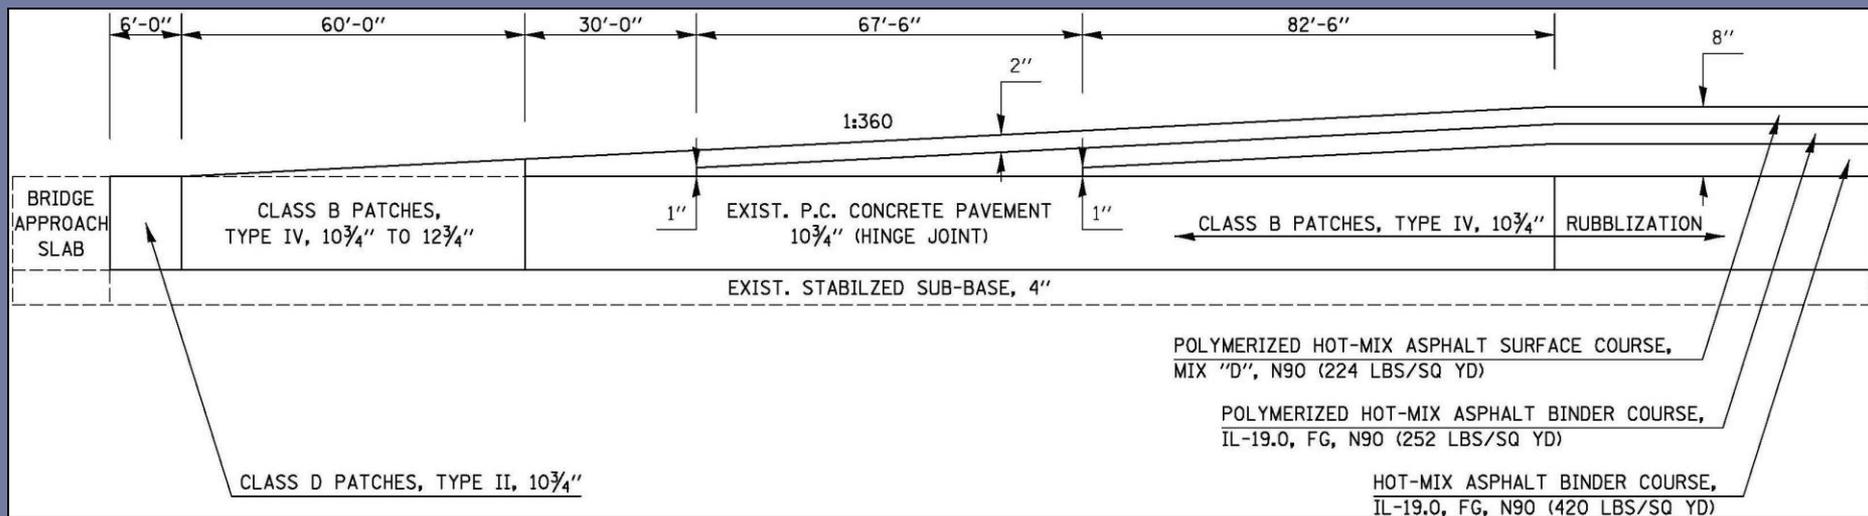
■ Profile Grade Considerations

- Maintain Existing Vertical clearance at all overhead structures
 - Three Span with vertical tie-down abutments that are not feasible to raise
 - Transition with variable thickness Class B Patch
- Meet existing profile grade at all mainline structures
 - Vaulted approach pavements
 - Transition with variable thickness Class B Patch

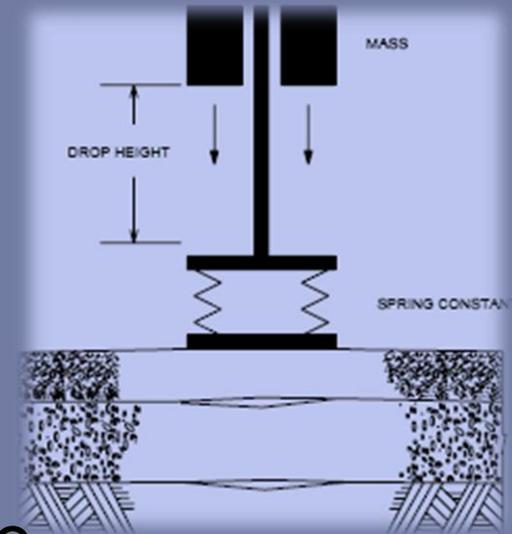
- Plan of Study and Evaluations
 - Annual inspections as visual distress surveys, rutting measurements, and falling weight deflectometer testing

- Field checks to watch for early
 - signs of fatigue cracking in the
 - wheelpaths or unusual signs of distress
